VSP-33
December 18, 1981

VENDOR SERVICE PUBLICATION

To: All Piper Distributors and CORPAC's
Subject: Bendix Service Bulletins 611, 616, 617, 619

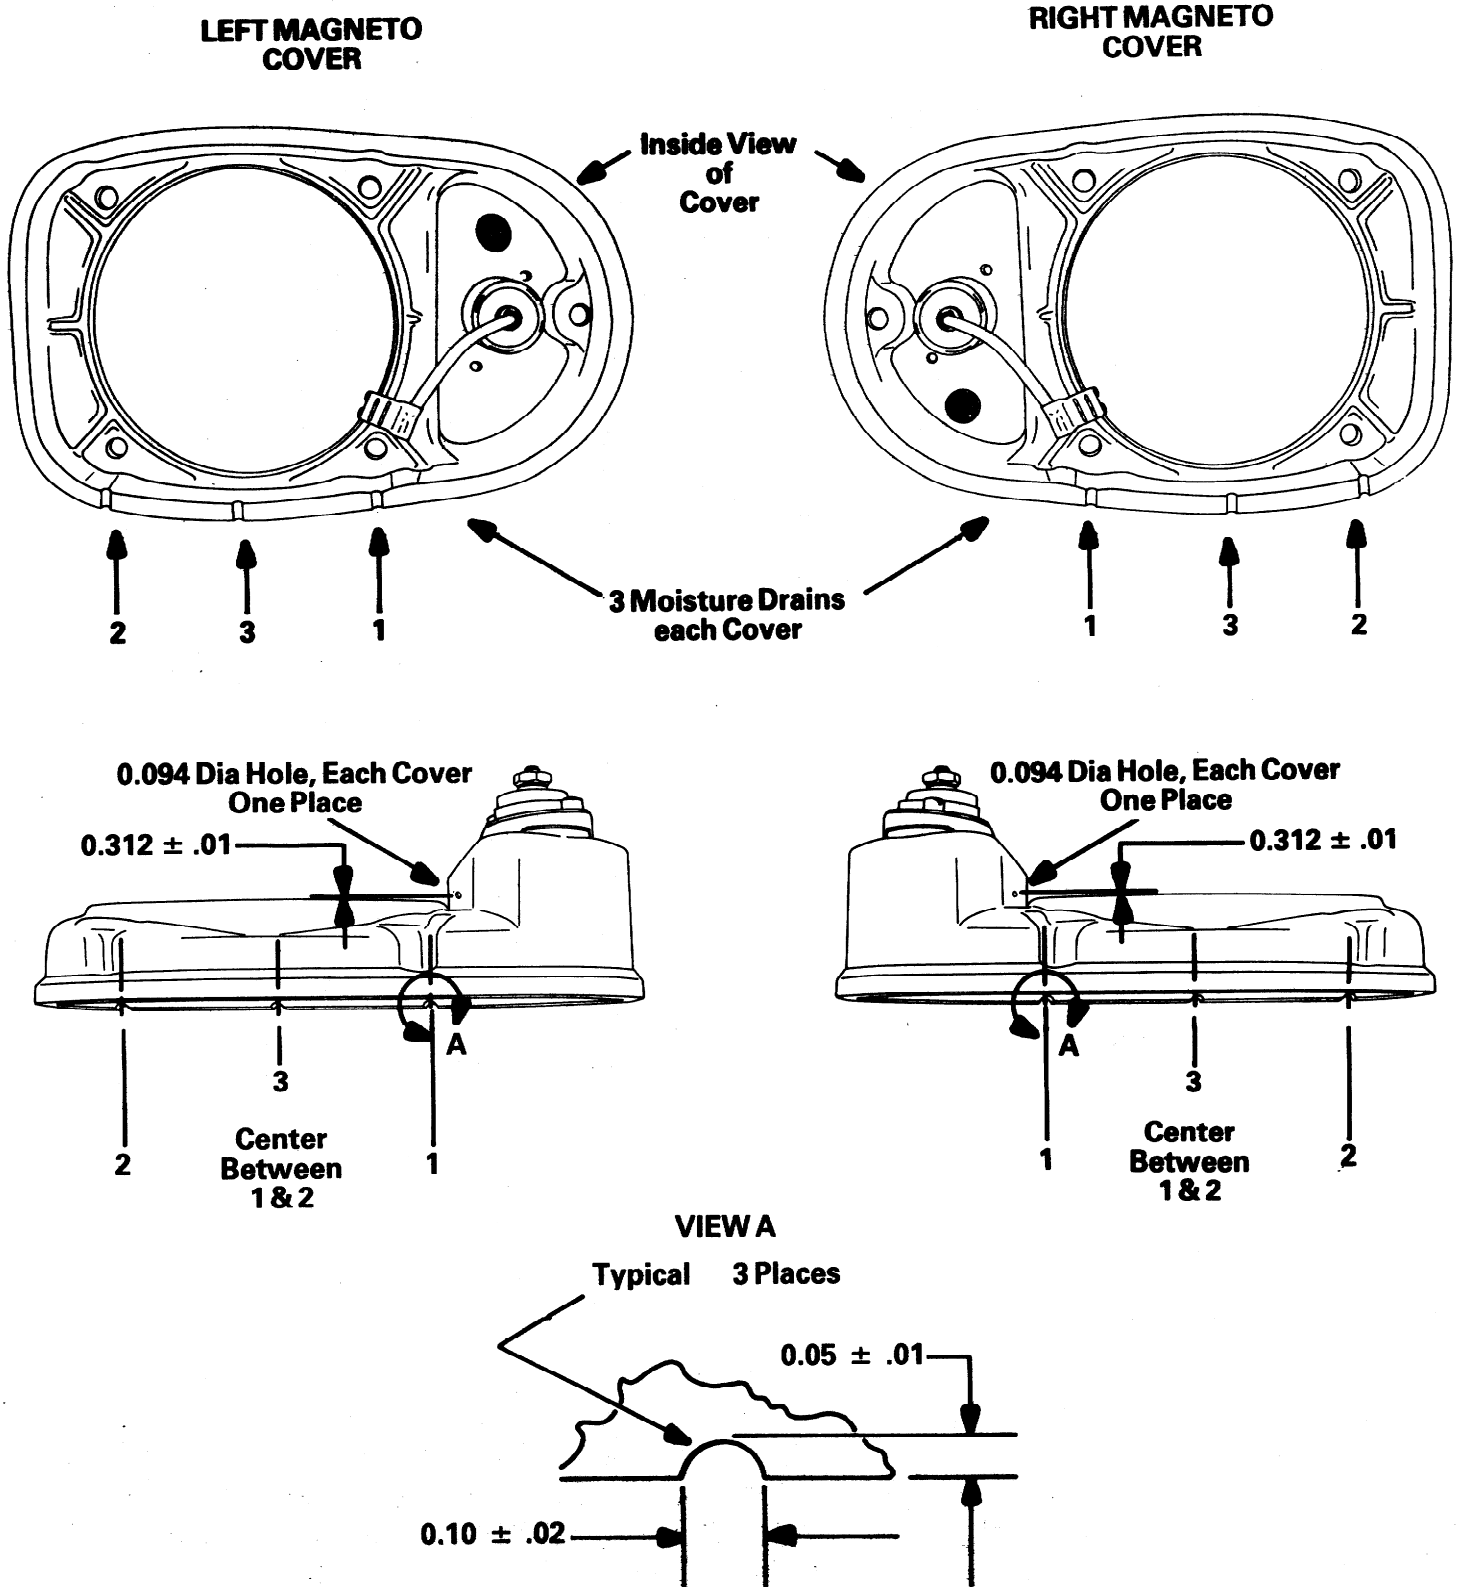
Figure 1. Location of Drain Holes

Field reports indicate that some operators of Teledyne Continental Engines of the 470 and 520 series are experiencing water ingestion in the S-1200

Series Magnetos. This moisture contamination may cause ignition difficulties, resulting in possible engine roughness. The addition of moisture drains and sealing of the screen vent in the magneto cover will provide a means for drainage of accumulated moisture and prevent moisture from entering the magneto through the screen vent.

1. Remove the magneto cover by removing the ignition harness adapter plate from each magneto and then removing the magneto cover securing screw. Pull the magneto cover away from the magneto and carefully pull the capacitor, and retard lead, if used, from the breaker flag terminal(s).
2. Using Figure 1 as a guide, lay out the positions for the moisture drains. Positions 1 and 2 are in line with the stud holes in the cover and position 3 is centered between 1 and 2. Using a small round file, create the three hemispherical recesses as detailed in view A, figure 1.

3. Lay out the position for drilling a 0.094 in. \pm 0.005 in. hole in the center of the ledge area of the covers and drill one hole in each cover using a 3/32" or No. 42 drill, as shown in Figure 1.

Do not allow the drill to penetrate through the cover and hit the housing of the capacitor which is directly in line with the hole being drilled. Mask drill bit for maximum allowable depth (1/4 in.).

4. Remove any burrs left during the filing and drilling operations on the covers and clean the covers of any metal shavings. Apply a thin coat of black enamel to the bare metal exposed during the filing of the moisture drains. Avoid getting paint on the adjacent cover-to-magneto mounting surface.

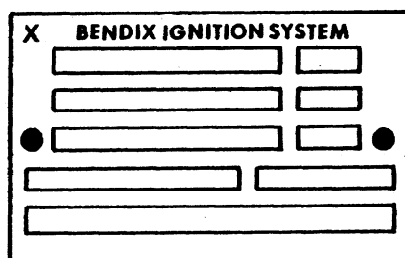
Figure 1. Location of "x" on Identification Plate

All D-3000/3200 Series (blue) Magnetos with Serial Numbers 100 through 1968 not identified by the letter "x" in the upper left corner of the identification plate (see figure 1). The "x" on the identification plate indicates previous compliance.

7. After the magneto has been reassembled with new serviceable gears, identify the magneto by stamping the letter "x" in the upper left corner of the identification plate, before the word "Bendix" (see figure 1).
