VENDOR SERVICE PUBLICATION

SUBJECT: AVCO Lycoming Service Bulletin No. 469

Bendix Service Bulletin No. 627

Distributor Block Kit Part Number 10-682056 (6 Cylinder) Dual Magneto Series

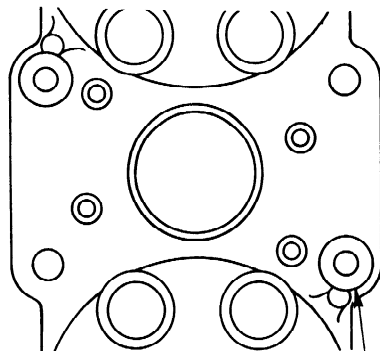
Figure 1

Reports indicate the flat washer P/N 10-4987 used on the distributor block securing screws P/N 10-35937-20 do not have sufficient diameter and may damage the block material when the screw is torqued.

To determine affected block, measure counter sunk hole to insure .427 inch diameter per figure 1. Reject block with counter sunk hole with .359 inch diameter only. All magnetos and spare blocks shipped from our facility, effective immediately, have a counter sunk hole with diameter .427 inch. See Figure 1.

Spare block kits shipped from the factory now include 4 flat washers, P/N 10-685548, as bag parts. The O.D. of the new washer is .396 inch. Original washer P/N 10-4987 with O.D. .328 inch should not be used with the block kit, P/N 10-682056.
