VENDOR SERVICE PUBLICATION

SUBJECT: Bendix Service Bulletin No. 629

Inspection and replacement of certain Bendix Aircraft Magneto Brown Distributor Blocks as used on turbocharged six (6) cylinder engines.

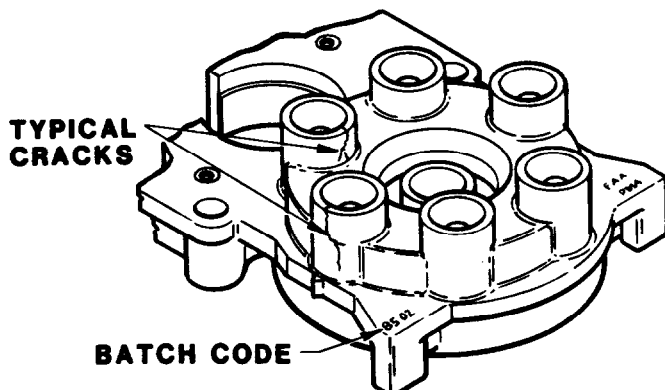
Figure 1
D-2000/D-3000 Series
Batch Codes 0000 through 8552

Field reports indicate some brown distributor block towers may crack (ref. Figures 1 through 3). Should the tower or towers crack the indications could be loss of ignition to the associated spark plug(s) or possible misfiring and/or cross firing of the engine.

1. Following published procedures, remove the harness cover or adapter plate from the Magneto. Using a high intensity light, inspect each distributor block tower for open cracks as shown in Figures 1 through 3.

CAUTION: BEFORE FURTHER FLIGHT, BLOCKS FOUND WITH CRACKS MUST BE REPLACED BY BLOCKS WITH BATCH CODES NOT LISTED AS AFFECTED UNDER THE "EQUIPMENT AFFECTED" SECTION OF THIS BULLETIN. FOLLOW PUBLISHED PROCEDURES.

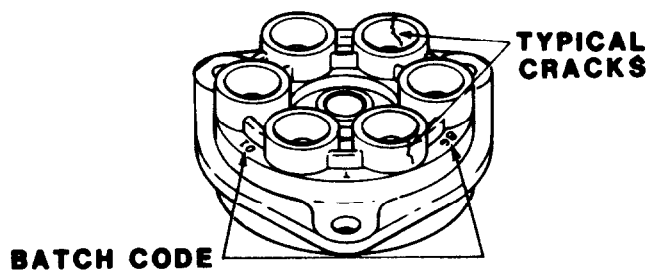
Figure 2
S-20/S-200 Series
Batch Codes 0000 through 8601

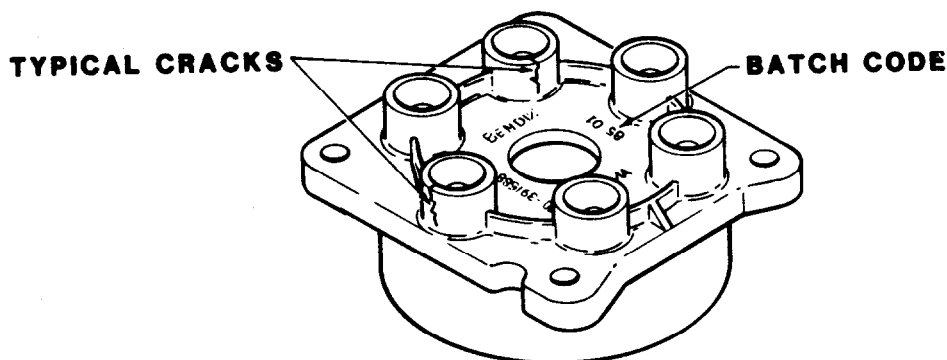
Figure 3
S-1200 Series
Batch Codes 0000 through 8601
