VENDOR SERVICE PUBLICATION

SUBJECT: Goodyear Aerospace Service Bulletin No. FT-77-1 Rev. B dated August 31, 1977; Recommended inspection of (Goodyear) fuel tanks, etc.

## SERVICE BULLETIN

SUBJECT: FUEL SYSTEMS - RECOMMENDED INSPECTION FOR POSSIBLE FUEL SEEPAGE FROM RUBBER-TYPE FUEL TANKS INCLUDING INSPECTION FOR POSSIBLE DETERIORATED OR SOFT RUBBER NIPPLE FITTINGS.

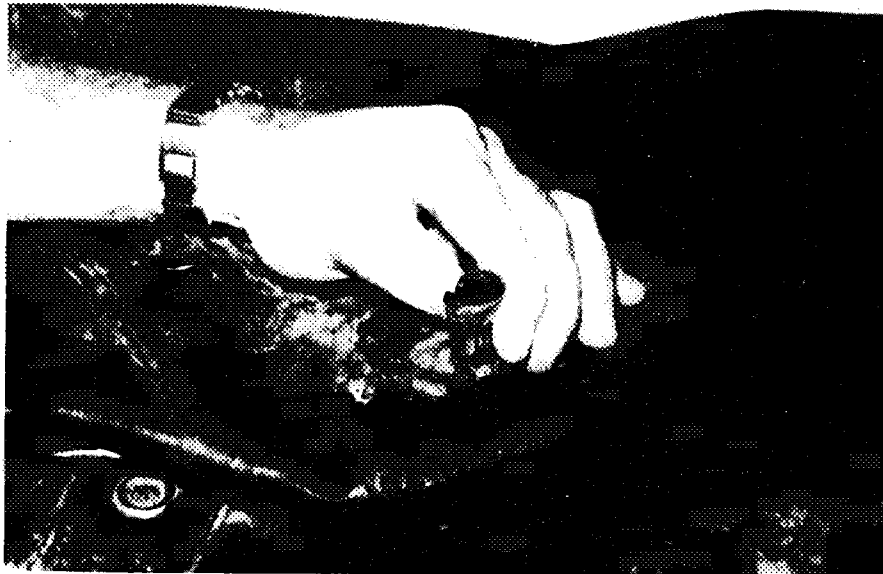
FIGURE 1

The fingernail test consists of using the fingernail to attempt to scrape the rubber off the nipple fitting (see Figure 1). If the rubber has not degraded, the fingernail will glide across the rubber without damage to the rubber. If an unsatisfactory condition exists, the fingernail will dig into the rubber. The rubber will have a consistency of either art gum or chewing gum. Usually the deteriorated rubber will have changed from a light tan color to a dark reddish-brown or greenish color depending upon color of fuel used.

5. Any fuel tank found seeping or with soft nipples should be replaced.
6. Reinstall fuel tank, fuel system and access plate and functionally check the fuel system.
