SERVICE BULLETIN

No. 562

Piper Aircraft Corporation

Subject: Annunciator Panel Oil Temperature Indicator System Modification

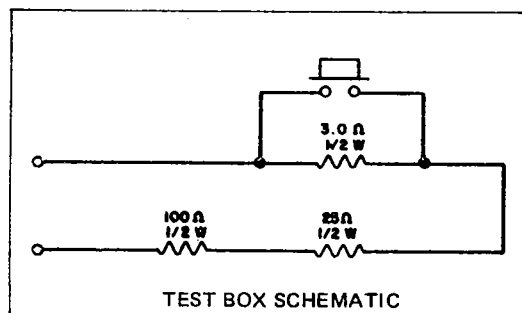
- c. Place a resistive load of 128 ohms across pin A and B of electrical harness connectors E116 and E217. Use a locally fabricated test box. (See Sketch at bottom of page for Test Box Schematic).

- j. Upon completion of adjustment procedure decrease the resistive load on the left oil temperature probe harness connector E116 by 3 ohms by pressing the switch on the test box. The left oil temperature annunciator panel light should extinguish. Repeat the same change in resistive load for the right oil temperature probe harness connector E217 and the right oil temperature annunciator light should extinguish.
