# SERVICE BULLETIN

No. 741

Piper Aircraft Corporation

PART I: Wing Flap Travel Restriction and Inspection of Wing Flap Flexible Drive Shaft

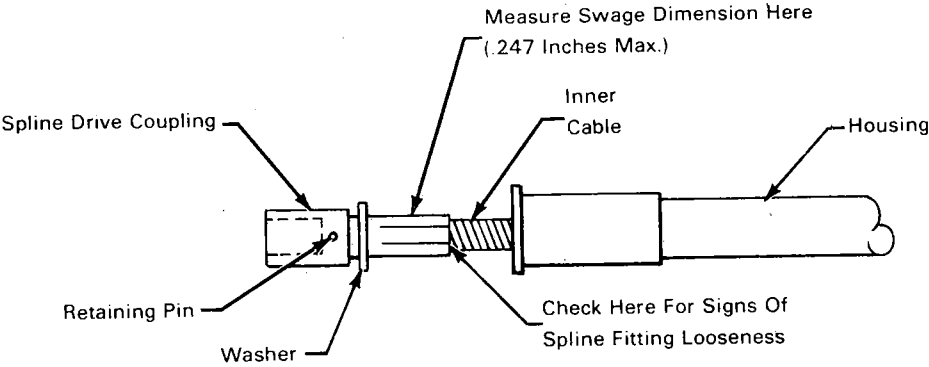
FIGURE 2

4. Visually inspect the flexible shaft splined drive coupling and retaining pin for evidence of looseness on the cable swage fitting. (Ref. Sketch D, Figure 2.)

5. Inspect the swaged fittings at both ends of the flexible shaft as follows:
  - a. Expose the swaged portion of the inner cable at the motor end by twisting the outer housing two (2) turns clockwise. The swaged portion of the cable should have eight (8) flats clearly visible and free from deep scratches or wear marks. (Ref. Sketch D, Figure 2.)

- b. Using a micrometer, or dial caliper, measure the diameter of the swage at each of the flats at the middle of the swaged portion of the cable. A total of four (4) measurements should be taken. If any of the measurements exceed .247 inches, replace the drive shaft.

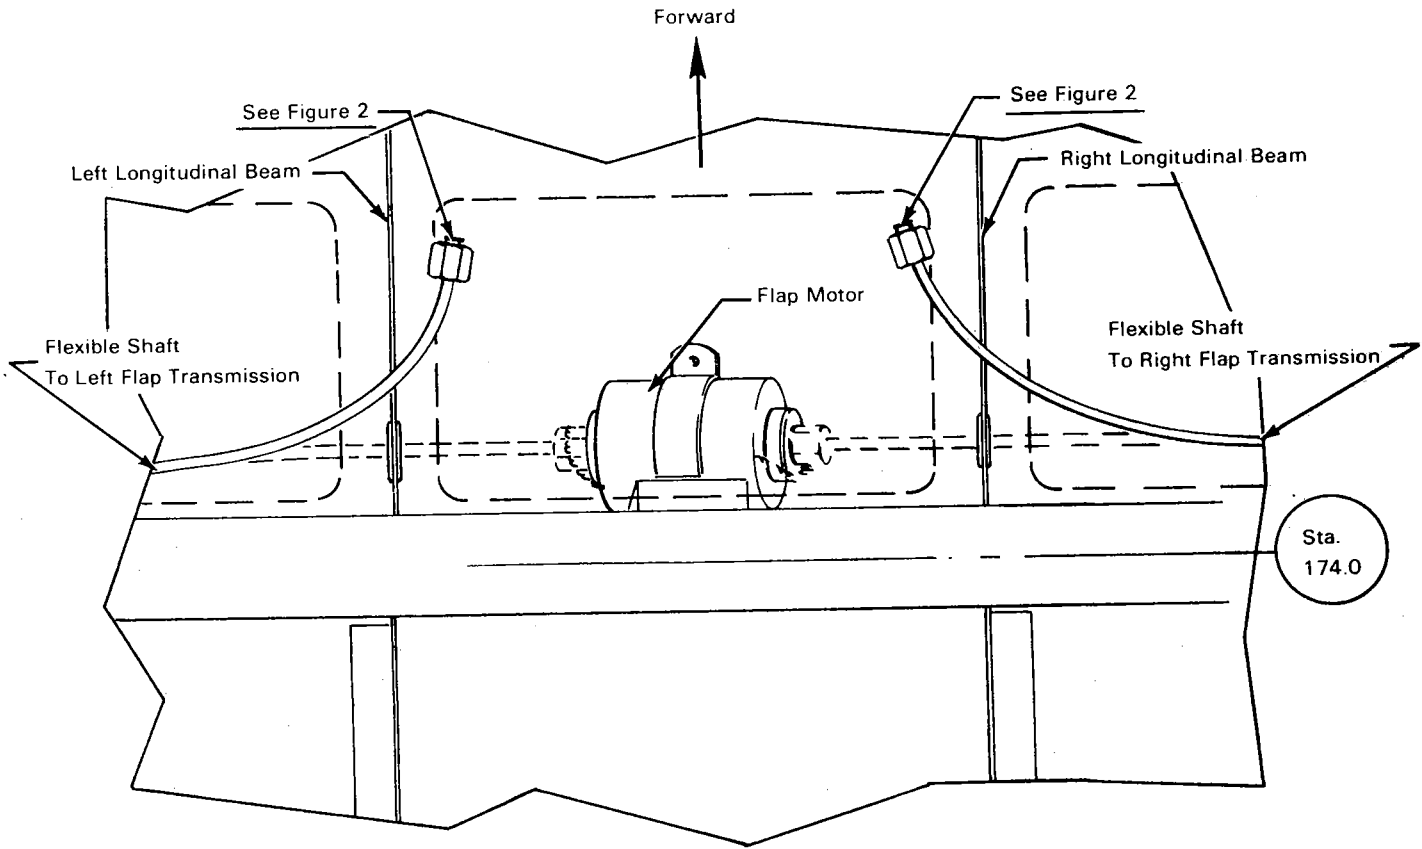
SKETCH D

- B. 3. Disconnect flexible shafts and remove the flap motor. Using caution not to damage the flexible shaft housing, route the flexible shafts outboard through the longitudinal beams (Ref Sketch D).

7. While holding the transmission end of the drive shaft stationary, twist the motor end one (1) turn clockwise and release. Inspect for evidence of movement between the inner cable and the swaged fittings at both ends. Turn cable one (1) turn counter-clockwise and repeat inspection. (Ref. Sketch D, E.) If movement or separation between the inner cable and the swage fitting is apparent, replace the flexible shaft assembly.

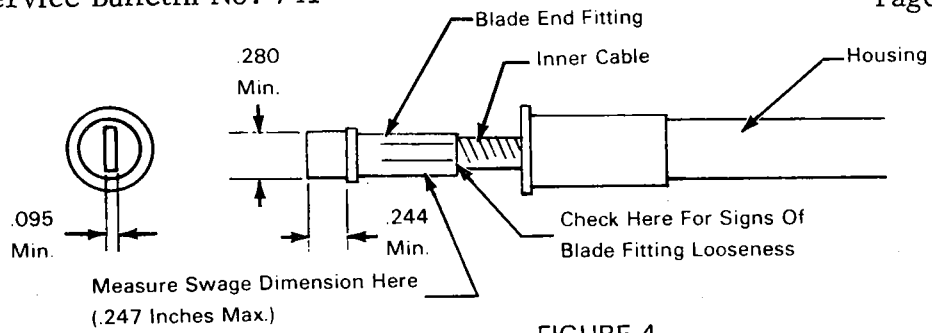
FIGURE 4

- d. Inspect the drive blade dimension as shown in Sketch E, Figure 4.
6. Inspect the internal splines of the drive coupling for evidence of wear. If splines are distorted or significantly worn, replace the drive shaft. Use the following method to determine if the amount of spline wear is acceptable.

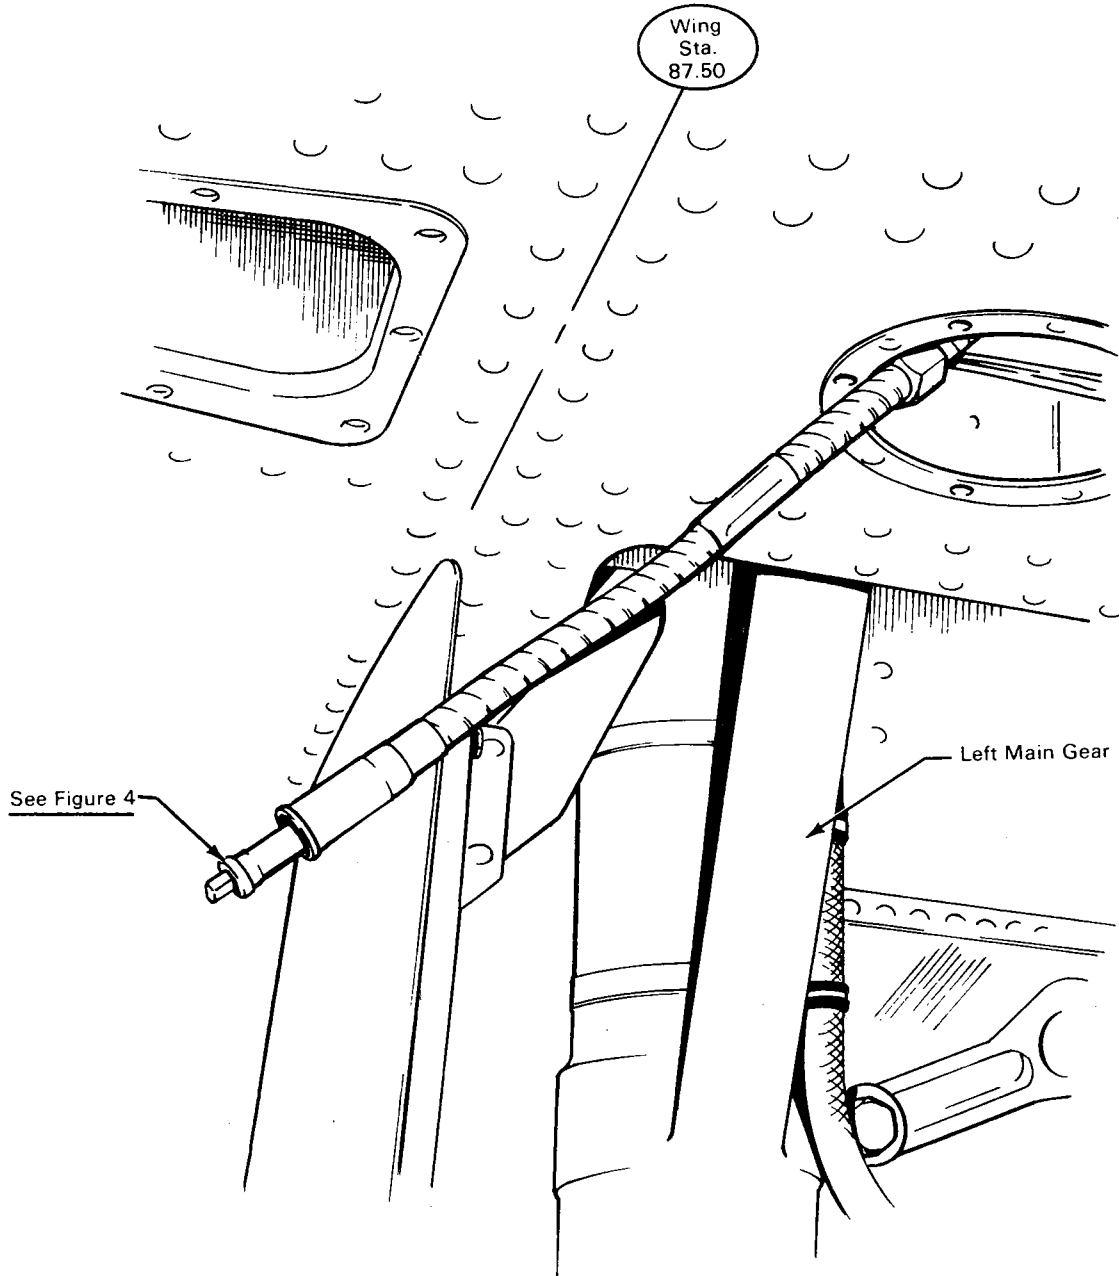
SKETCH E

- c. Disconnect drive shaft from the flap transmission. Using caution not to damage the shaft housing, route inboard through the Sta. 87.50 bulkhead. (Ref Sketch E.) Inspect the swaged portion of the drive blade fitting end as described in "a" and "b" above.

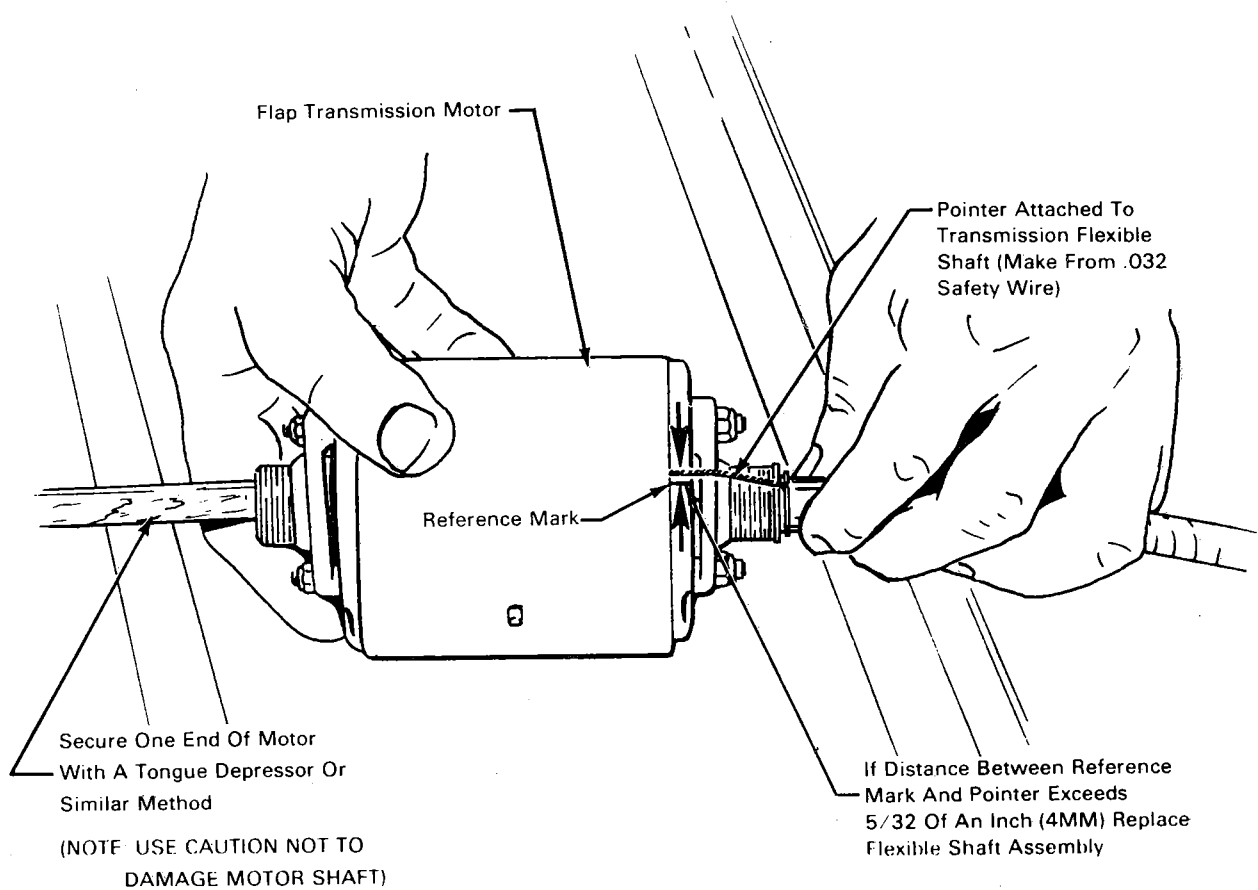
FIGURE 5

- a. Twist a piece of .032 safety wire around the swaged fitting at the motor end of the drive shaft to form a pointer (Ref Sketch F, Figure 5). With one end of the flap motor armature shaft secured engage the opposite end into the flexible shaft spline.

- b. Hold the spline end of the flexible shaft securely with one hand, and gently turn the flap motor to remove rotational play in the splines. Place a reference mark on the motor housing adjacent to the wire pointer (Ref Sketch F, Figure 5). Turn the flap motor gently in the opposite direction to remove rotational play and place another reference mark on the motor housing. If the distance between these two marks exceed 5/32 of an inch (4 mm) replace the flexible shaft assembly (Ref Sketch F, Figure 5).
