Piper Aircraft Corporation  
Lock Haven, Pennsylvania, U.S.A.

# SERVICE No. 773A BULLETIN

Bulkhead (Fuselage Station 332.0)  
Inspection

PA-31T Cheyenne/Cheyenne II  
PA-31T1 Cheyenne I/IA

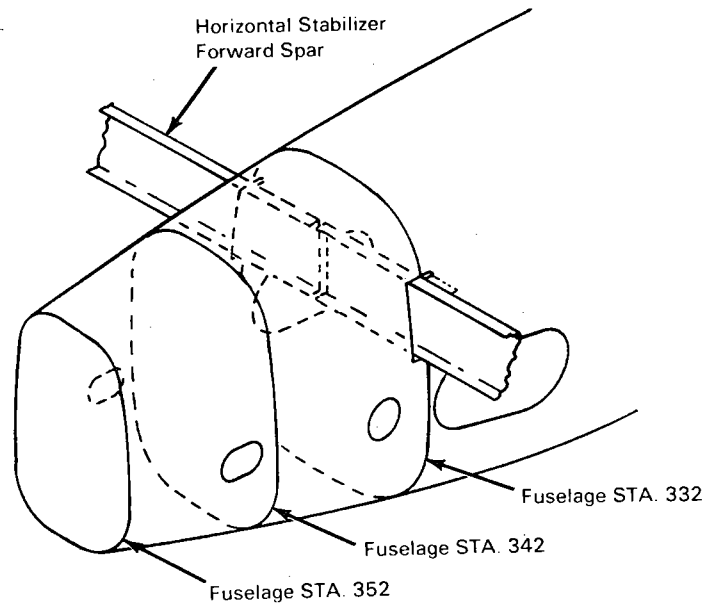
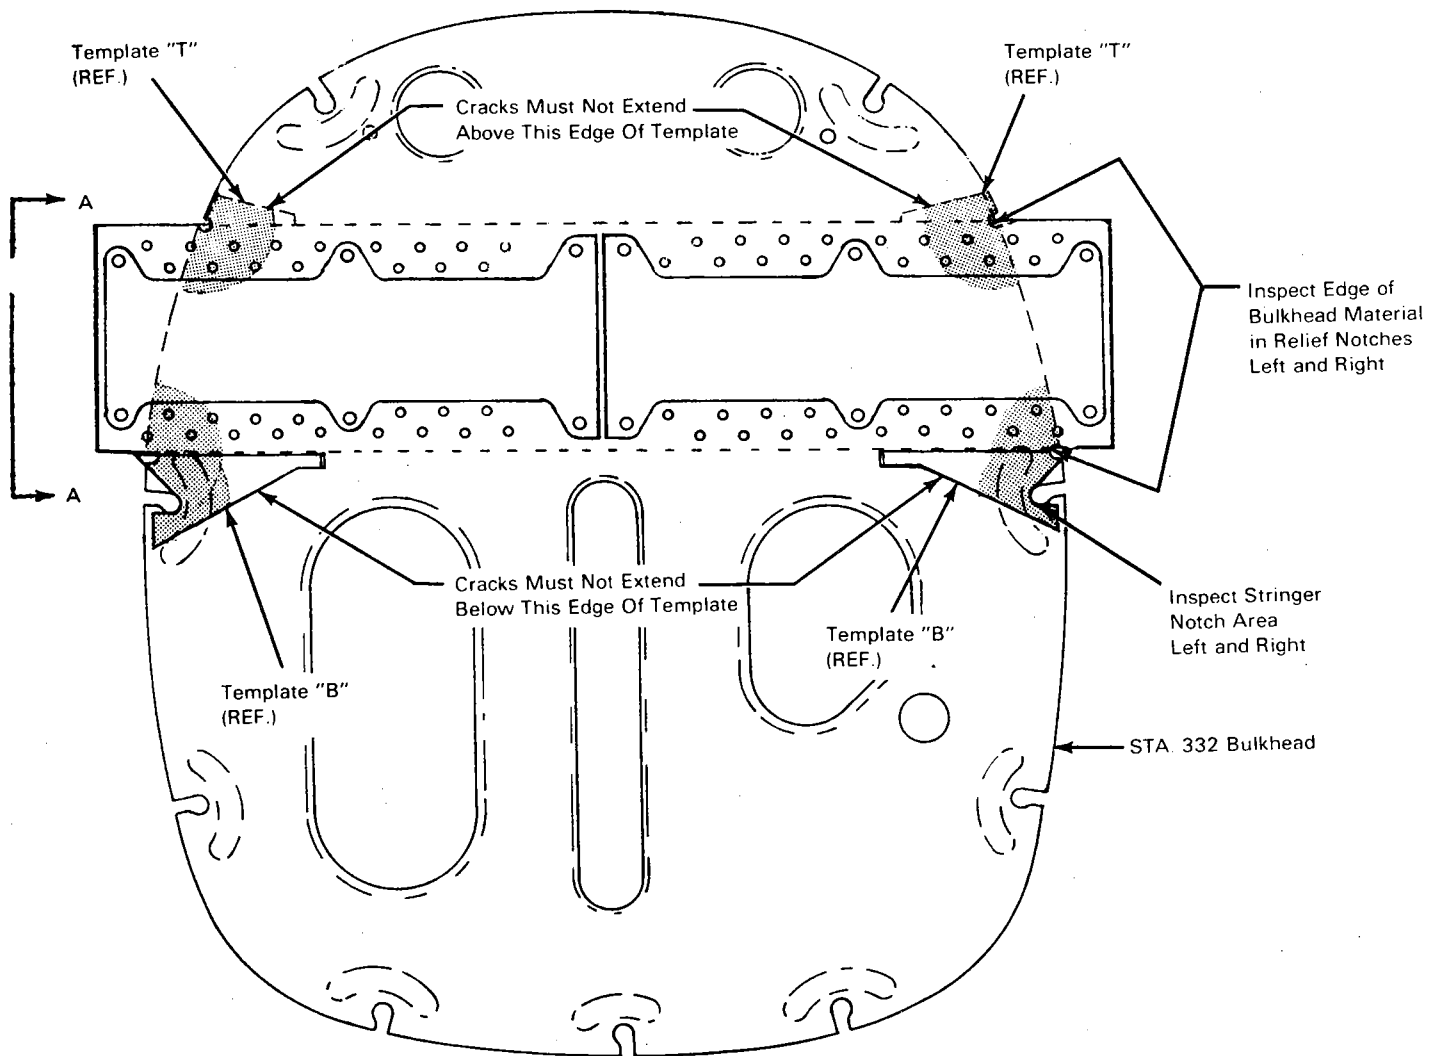
REAR VIEW OF BULKHEAD LOOKING FORWARD

Field reports indicate that cracks can develop in the fuselage bulkhead (Part No. 45583-08 on PA-31T, PA-31T1 and PA-31T2; Part No. 45583-10 on PA-31T3) at Fuselage Station 332.0. Left uncorrected, such cracks could propagate and result in a loss of structural integrity.

LIMITATIONS: Cracks which originate at the relief notches or stringer cut-outs (See Sketch A) which do not exceed 1.5 inches in length and which do not extend above the top edge of Template "T" or below the bottom of Template "B" may be repaired per Instruction 2.b.

Bulkheads With Cracks In Areas Denoted By Shading (See Limitations) May Be Repaired Per Instruction 2b.

1. Gain access to the bulkhead area shown in Sketch A by removing the wrap-around fairings from the horizontal stabilizer to the fuselage and the access plates in the Station 332.0 area.
2. Using Dye Penetrant Inspection method, inspect the Fuselage Station 332.0 bulkhead for cracks in the areas shown in Sketch A.
  - a. If no cracks are found to exist proceed to Instruction 3 below. A repetitive inspection is required at each 200 hours of operation.
  - b. If cracks are found, and cracks do not exceed the following limitations, cracks must be stop drilled and Reinforcement Kit 764 983 must be installed before further flight.

- c. If cracks are found to exceed the specified limitations, replace bulkhead assembly with Reinforced Bulkhead Assembly Part No. 45583-16 or 45583-17 before further flight.
3. Reinstall fairings and make appropriate logbook entry of compliance.

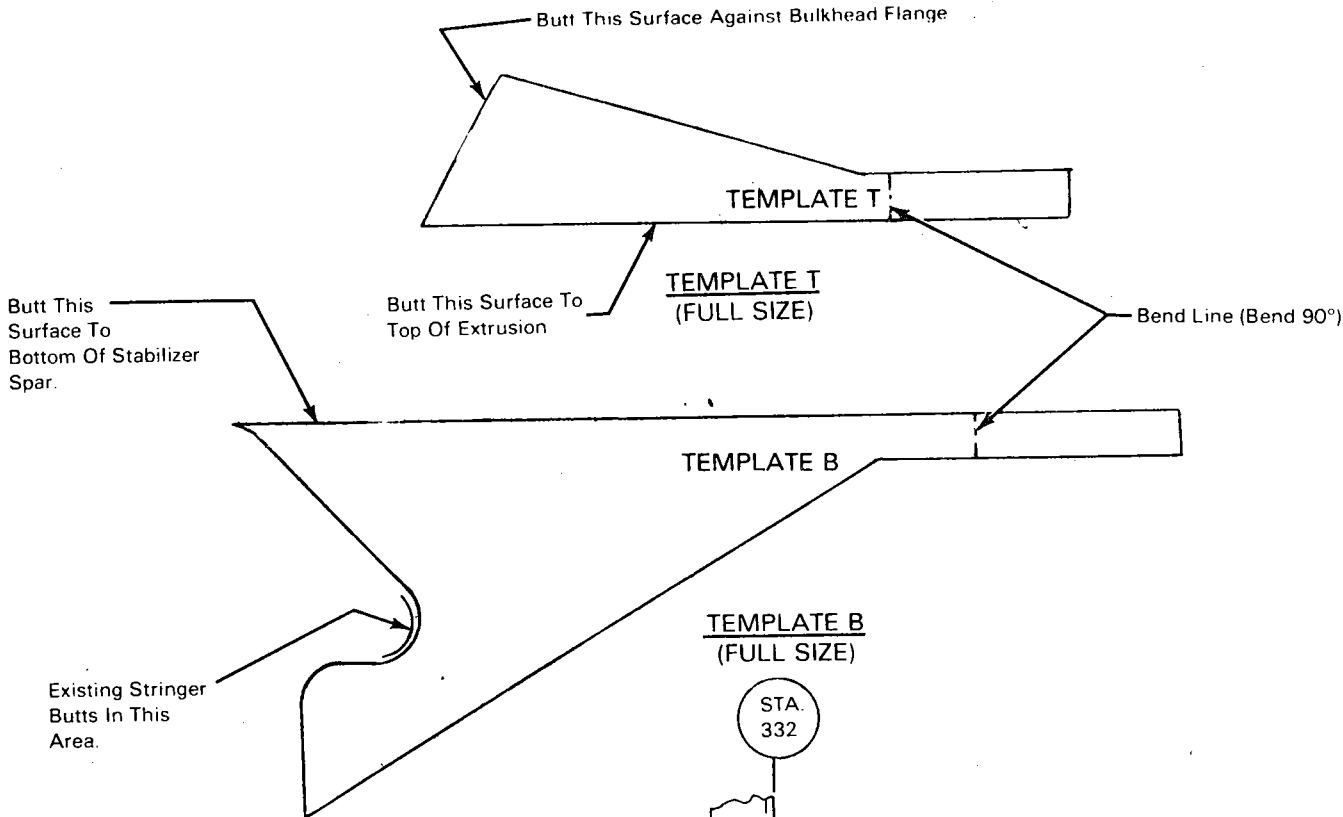
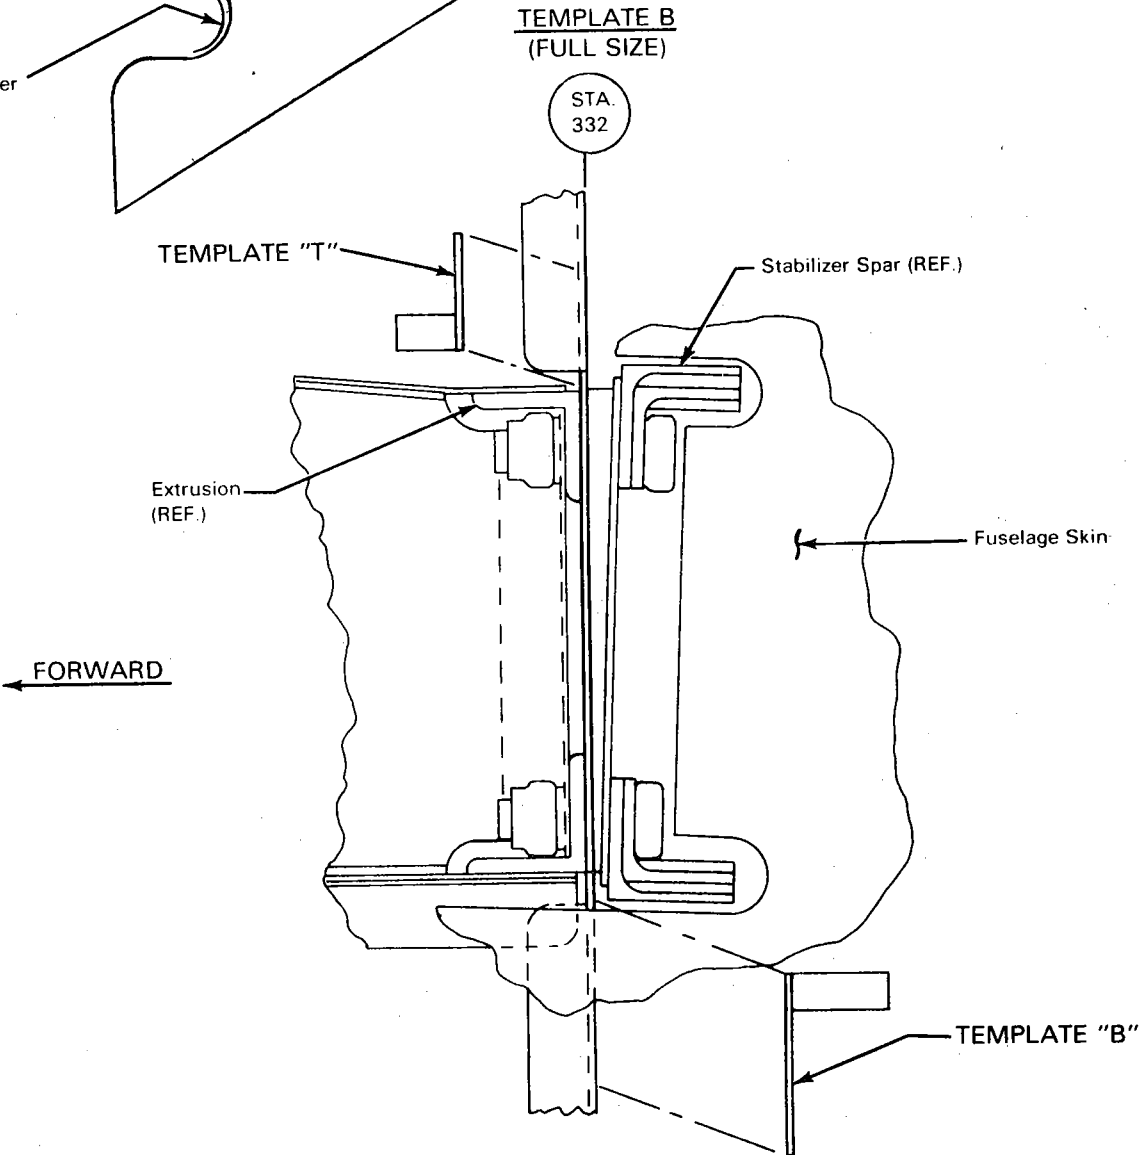
SKETCH "B"

VIEW A-A  
(Left Side Shown, Right Side Opposite)
