# SERVICE *No.884* BULLETIN

Piper Aircraft Corporation  
Ft. Worth, Texas, U.S.A.

April 8, 1988

Lock Wiring of V-Band Couplings

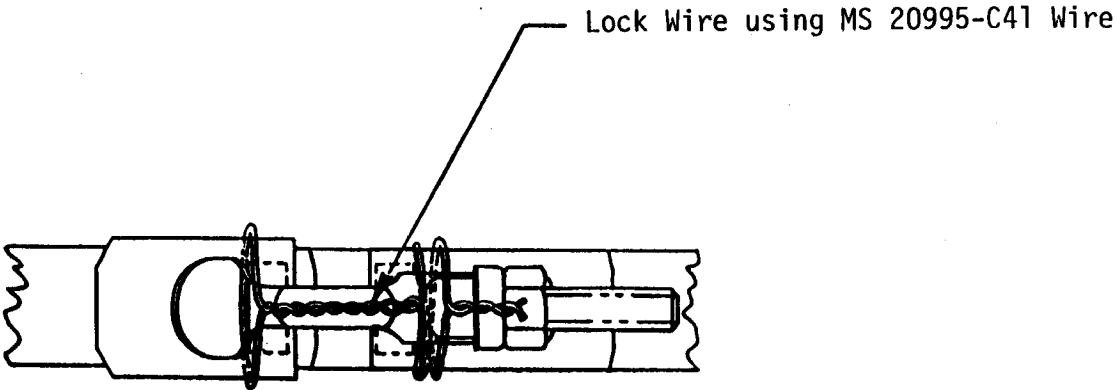
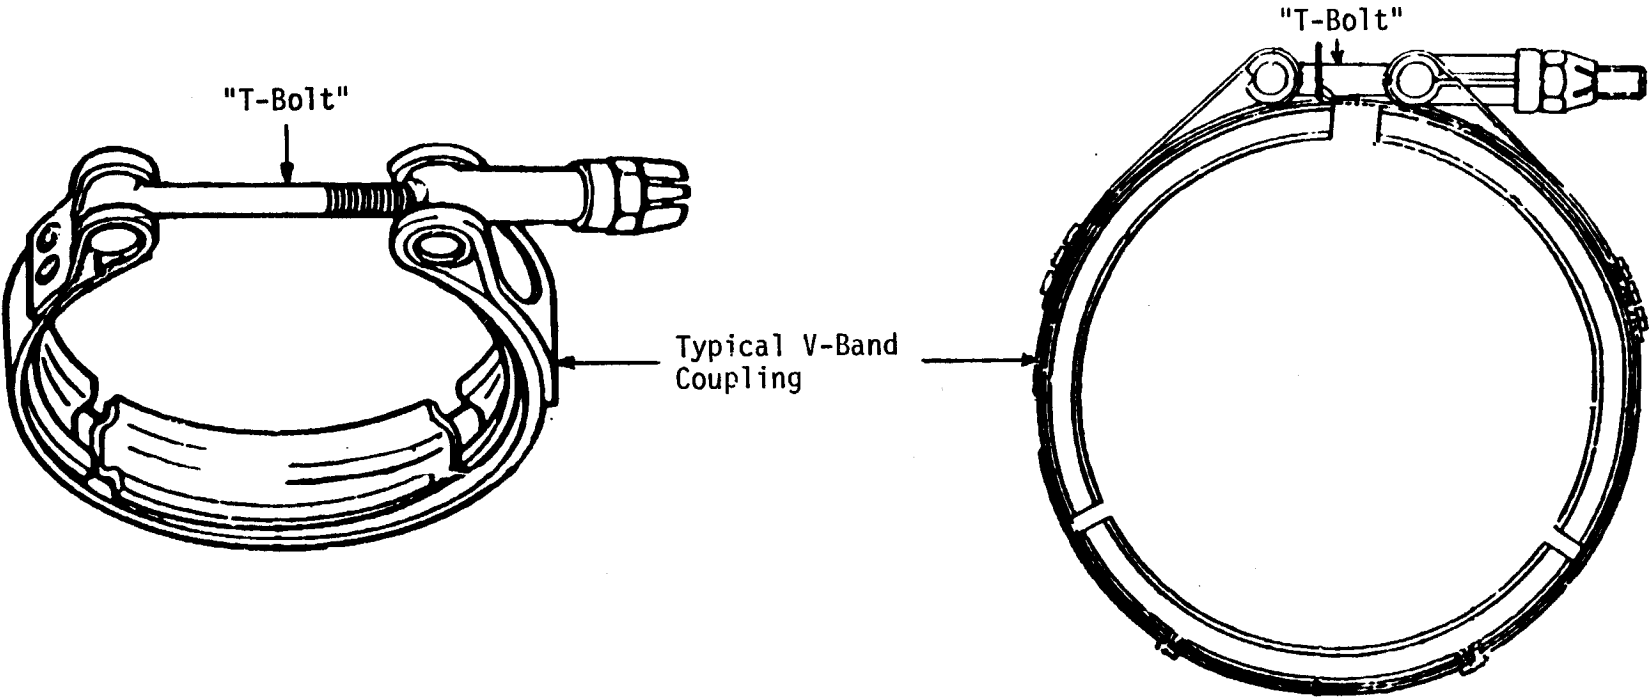
SKETCH "A"

**PURPOSE:** Reports have been received of broken "T-bolts" in the V-Band Couplings used in the exhaust, bleed air and cabin heat systems on various Piper Airplanes. The failure of a T-bolt can allow the coupling to separate, permitting hot exhaust gases or bleed air to be expelled, creating a fire hazard.

1. Refer to the applicable parts catalog to determine the number and location of V-Band Couplings on the affected aircraft.
2. Inspect all V-Band Couplings for security and integrity of T-bolts and lock wire (if installed). Refer to Sketch "A" attached.
3. If lock wire is damaged or missing, lock wire coupling using MS20995-C41 wire. Refer to Sketch "A".
4. Make an appropriate logbook entry of compliance with this Service Bulletin.
