Piper Aircraft Corporation  
Vero Beach, Florida, U.S.A.

# SERVICE *No.* 923 BULLETIN

Date August 16, 1989 M

Main Landing Gear Actuator  
Reinforcement Bracket Replacement

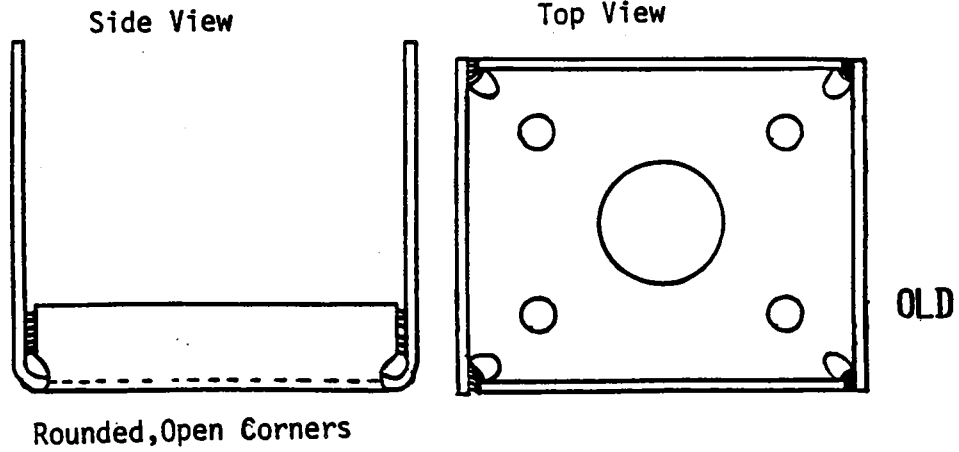
Some aircraft may have the new actuator reinforcement brackets (Piper Part Number 73786-02) installed as replacement parts. Refer to Sketch "A" for identification of Piper Part Numbers 40776-00 (old) and 73786-02 (new). Aircraft with Piper Part Number 73786-02 installed on both sides are in compliance with this Service Bulletin.

1. Place aircraft on jacks.
2. Locate the main landing gear actuator reinforcement bracket on the left and right wings. See Sketch "B" (attached).
3. Remove and discard original Actuator Reinforcement Brackets, Piper Part Number 40776-00. Install Piper Part Number 73786-02, as shown in Sketch "C".
4. Inspect and perform gear retraction per appropriate Chapter in the Maintenance Manual.
5. Remove aircraft from jacks.
6. Make appropriate logbook entry of compliance with this Service Bulletin.

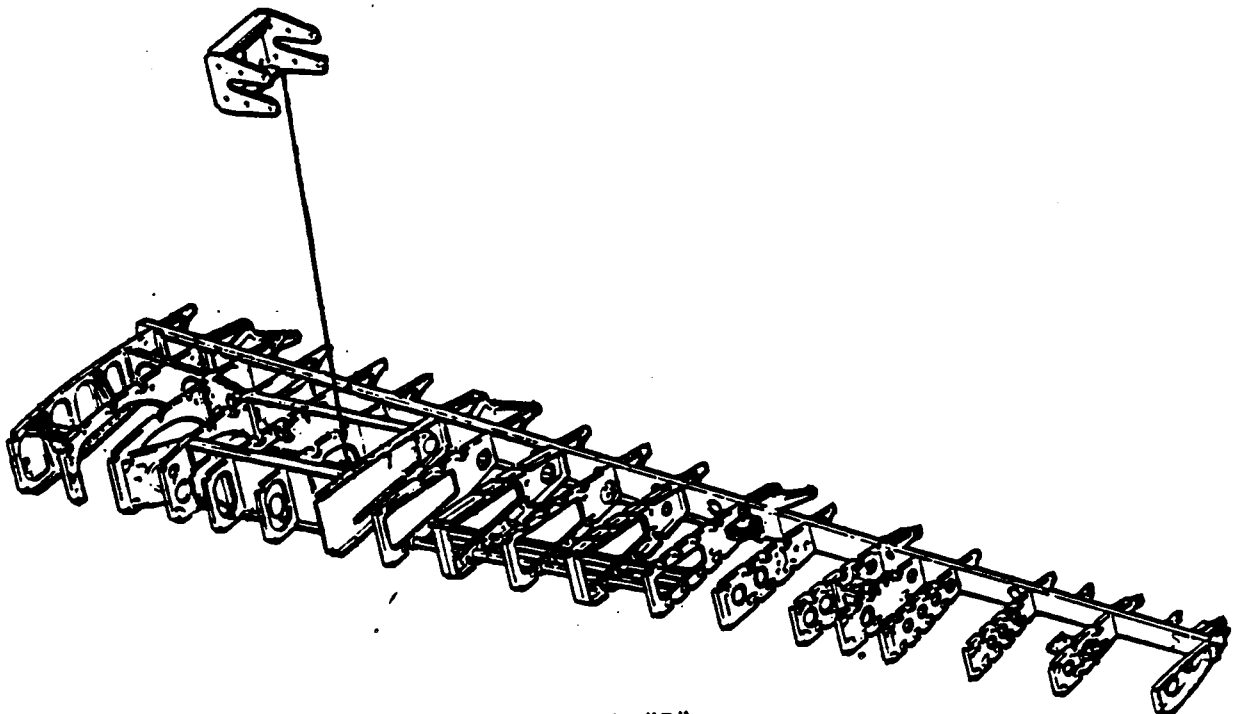
Sketch "B"

PURPOSE: Field reports have been received of cracks developing in the Main Landing Gear Actuator Reinforcement Bracket(s). If this condition exists and is left uncorrected, failure of the bracket(s) could occur disabling the main landing gear actuator on the affected side(s).
