SERVICE *No. 974* BULLETIN

DATE: October 19, 1994

Aileron Hinge Inspection and Replacement

PA-31, 31-300, 31-325 Navajo
PA-31-350 Navajo Chieftain
PA-31-350 T1020
PA-31P-350 Mojave
PA-31T3 T1040

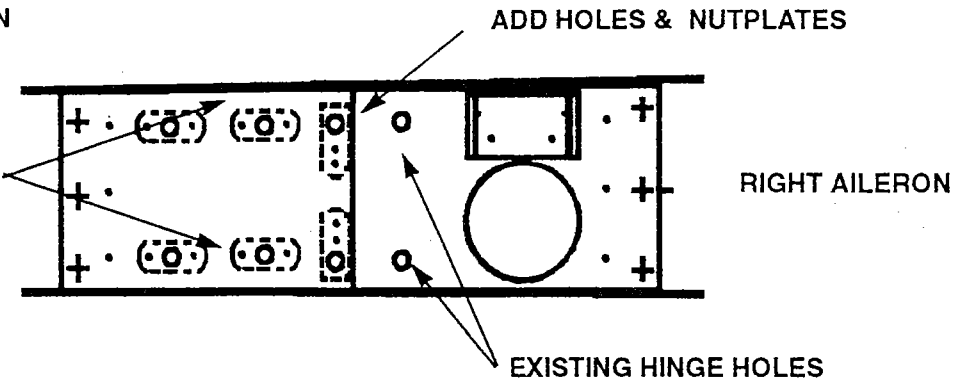
TYPICAL AILERON

Reports have been received of small cracks developing in the aileron spar and reinforcement doubler beneath the inboard aileron hinge attachment point.

INSPECT:
CRACKS WILL
APPEAR ALONG
SPAR FLANGE
AND AT ATTACH
HOLES.

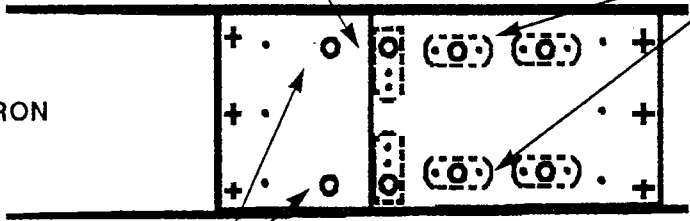
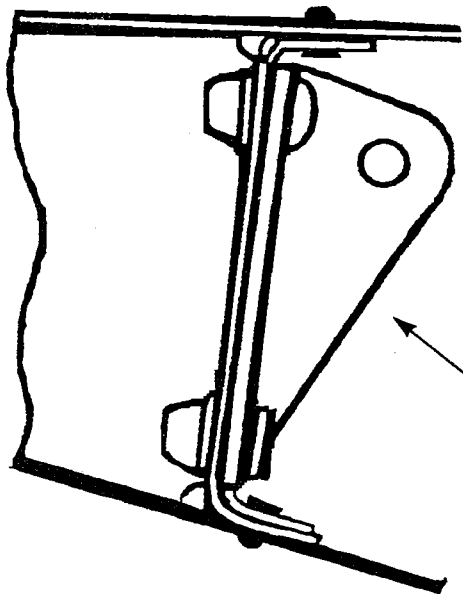
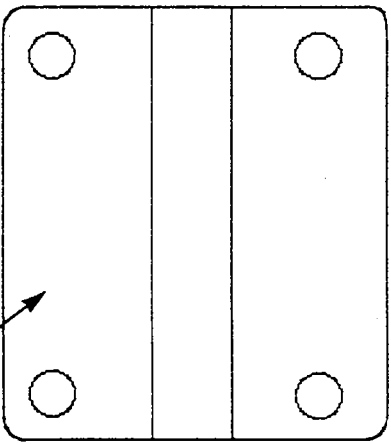
SKETCH A

EXISTING HINGE HOLES

INSPECT:
CRACKS WILL
APPEAR ALONG
SPAR FLANGE
AND AT ATTACH
HOLES.

6. Install the new Hinge Bracket, Piper Part Number 74461-02 (left) and 74461-03 (right), utilizing three (3) each AN3-5A Bolts, Piper Part Number 401-266, three (3) each AN960-10 Washers, Piper Part Number 407-564, and one (1) each MS24694S53 Flush Screw, Piper Part Number 410-035, per Hinge Bracket.

7. If no cracks are present, it will be necessary to drill additional holes and add two (2) additional nutplates to the existing aileron spar assembly. Temporarily install the new hinge bracket to the aileron spar. Using the new hinge bracket as a template, drill two (2) new .191 inch holes in the spar to match.

ADD HOLES & NUTPLATES

INSTALL NEW HINGE
P/N'S 74461-02 (LEFT)
AND 74461-03 (RIGHT)
