The New Piper Aircraft, Inc.
2926 Piper Drive
Vero Beach, Florida, U.S.A. 32960

SERVICE *No. 1054* LETTER

**PROPELLER CONTROL ARM ATTACHMENT
INSPECTION**

PA-31T Cheyenne/Cheyenne II
PA-31T1 Cheyenne I/IA

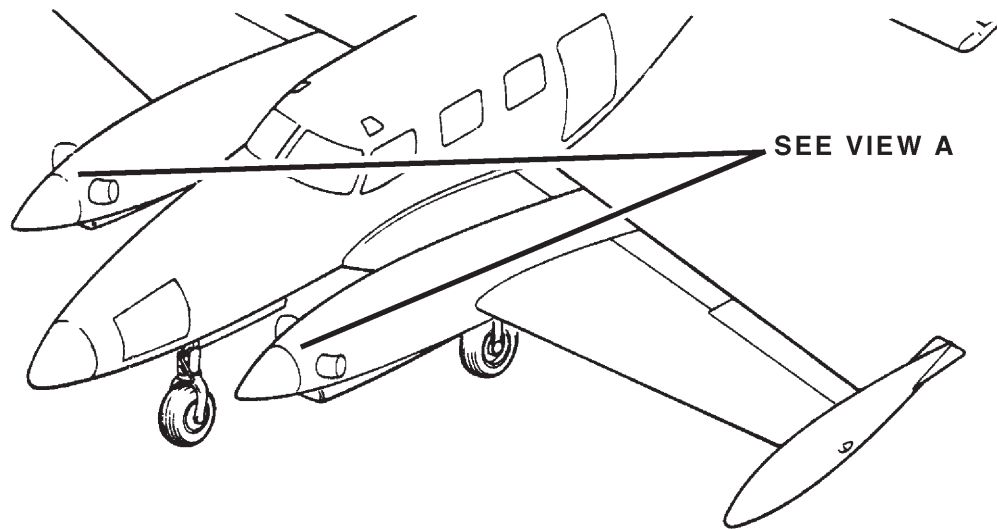
Bracket Location
Figure 1

Propeller Governor Control Arm Linkage - **100 Hour Special Inspection**
(See Figure 1 for general location)

Each 100 hours of operation, inspect the propeller governor control arm linkage bracket (P/N 51623-000) for condition and security.
