# SERVICE LETTER

No. 755C

Piper Aircraft Corporation

SUBJECT: Landing Gear Lock Actuator Rod  
and Rod End Bearing Inspection/  
Replacement.

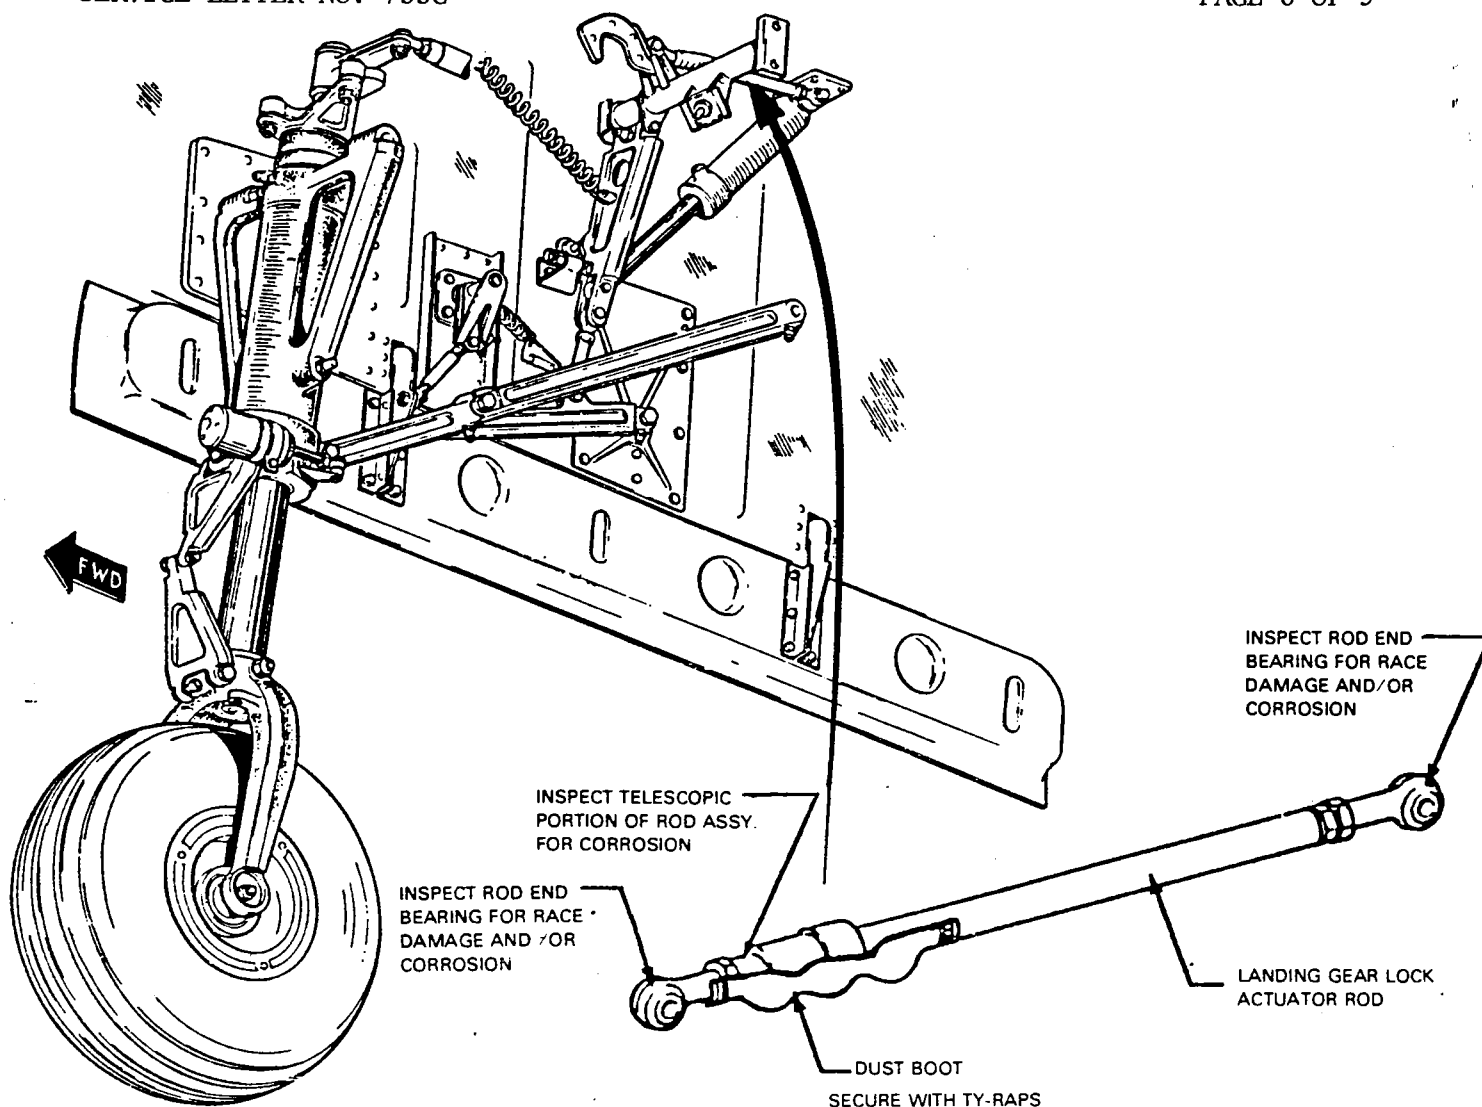
SKETCH A

## Nose Gear Actuator Rod and Rod End Bearing Inspection

1. Locate and remove the nose gear lock actuator rod assembly from aircraft as shown.
2. Loosen the clamp attaching the dust boot to the landing gear lock actuator rod. Slide the dust boot back to expose the telescopic portion of the actuator rod assembly.

3. Inspect the telescopic portion of the landing gear lock actuator rod for evidence of corrosion.
  - a. If corrosion is evident, the landing gear lock actuator rod assembly should be replaced.

- b. If no corrosion exists, lubricate the telescopic portion with MIL-G-81322, 81827 or MIL-G-21164C lubricant.
4. Reposition and secure dust boot on each landing gear lock actuating rod assembly.

5. Inspect each rod end bearing for evidence of race damage and/or corrosion.
  - a. If corrosion is evident and/or ball and race of bearing shows evidence of damage (ball must rotate freely in race), it will be necessary to replace that bearing.

- b. If existing bearings show no evidence of corrosion or damage, lubricate bearings with MIL-L-7870 lubricant.
6. If a new main gear lock actuator rod assembly (assemblies) is being installed, lubricate the telescopic portion as described in 3b above, and the rod end bearings with MIL-L-7870 lubricant. Install existing dust boot on actuator rod assembly as shown.

7. Reinstall the nose gear actuator rod assembly on aircraft. Check system function and rigging; adjust as necessary using the appropriate Navajo Service Manual. Refer to Sketch "C" for the correct method of adjusting rod end bearings.

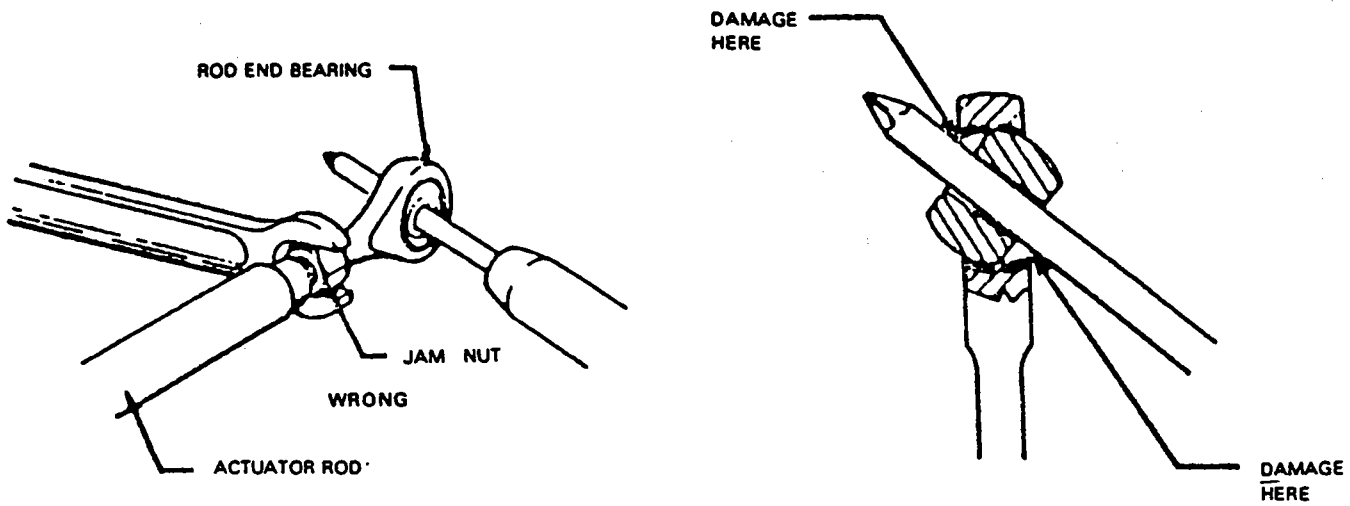
NOTE: It has been found that rod end bearings race damage - incurred during maintenance/rigging activity - has resulted in landing gear system difficulties and/or premature rod end bearing replacements. This Service Release also provides a recommended method for backholding the bearing assembly while adjusting the adjacent jam nut to prevent bearing race damage (refer to attached instruction data for details).

IMPROPER METHOD OF ADJUSTING ROD END BEARINGS  
(RESULTING IN LOCKED BALL)

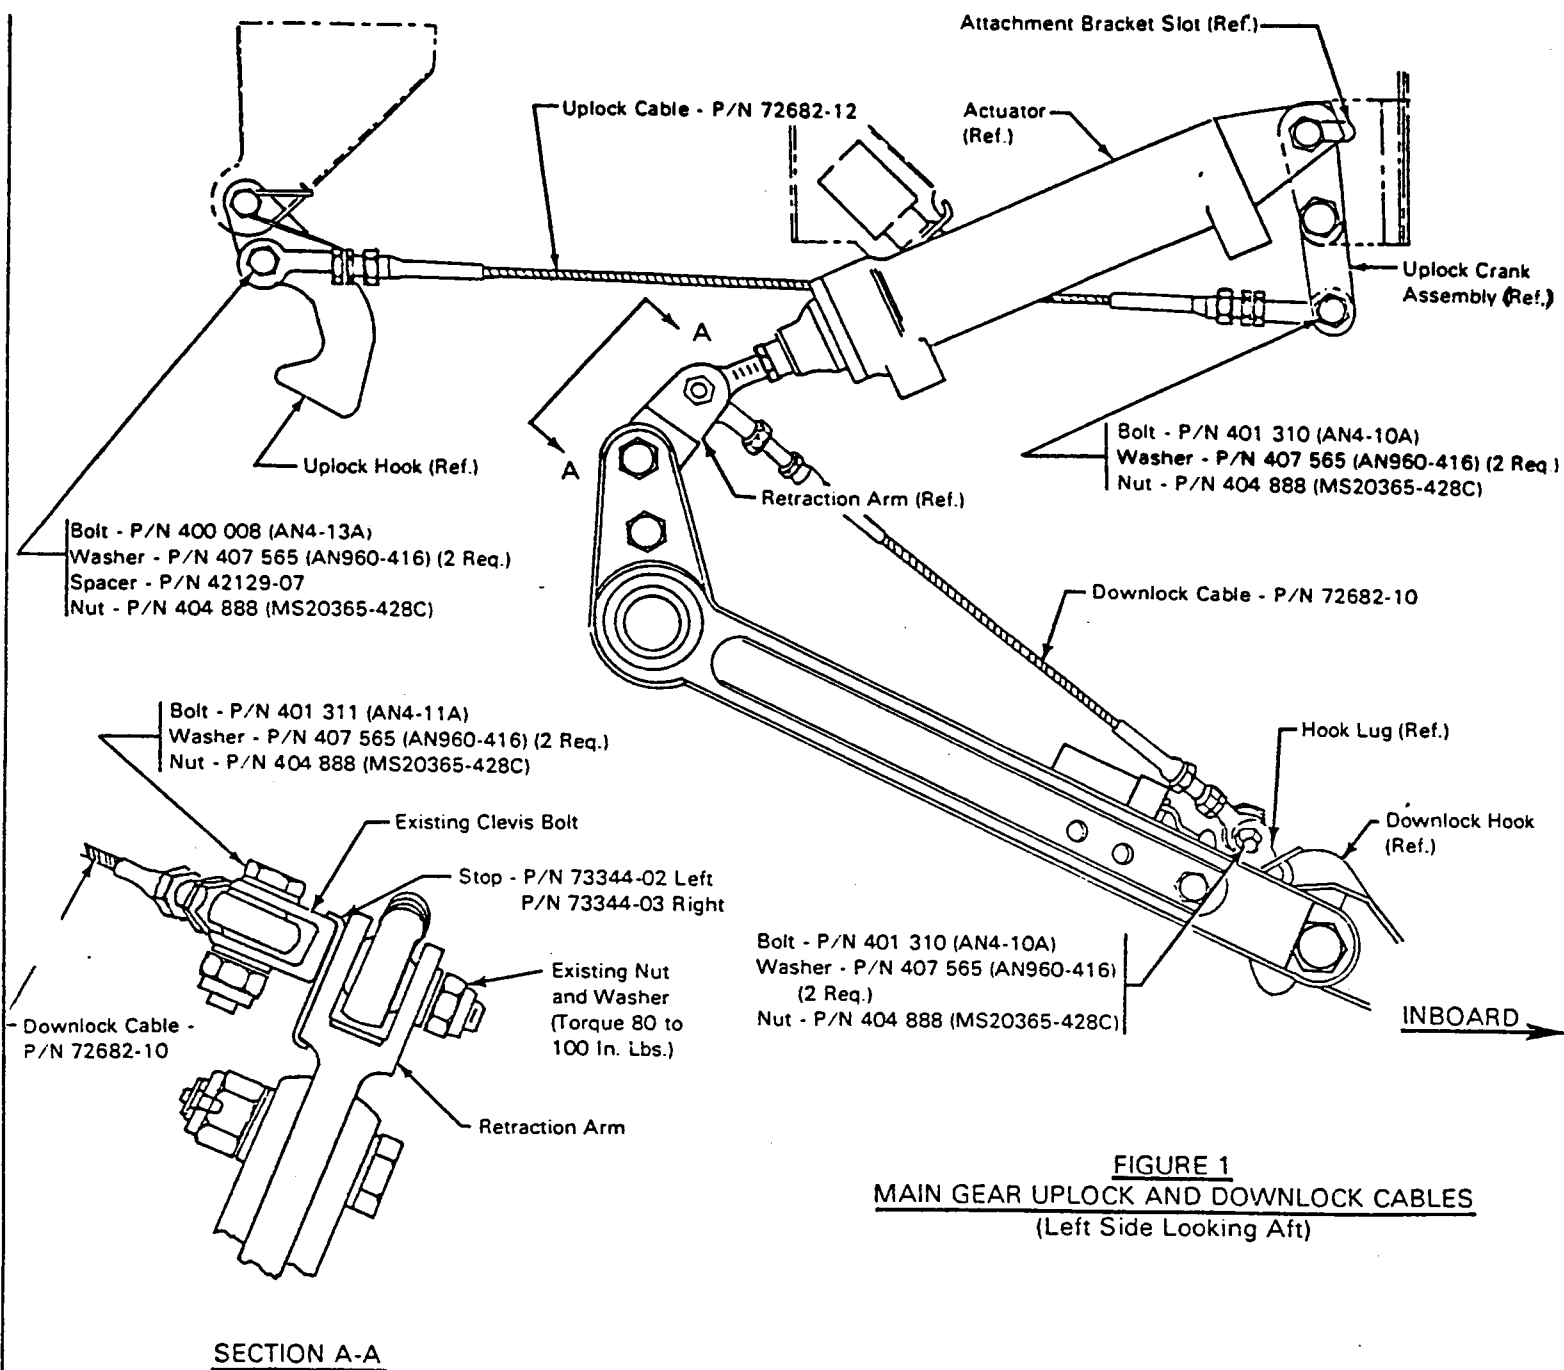
SKETCH D

PURPOSE: Above affected models and serial numbers of aircraft were delivered with the new landing gear uplock and downlock cable assemblies. Installation of these stops between the retraction arm and clevis bolt will prevent possible rotation of the downlock cables and insure safe gear indications.

FIGURE 1  
MAIN GEAR UPLOCK AND DOWNLOCK CABLES  
(Left Side Looking Aft)

NOTE: Refer to Sketch D, Section A-A of this Service Letter for anti-rotation stop installation.

1. Remove nut and washer from the clevis bolt (fork) connecting the down-lock cable to the retraction arm.
2. Pull out the clevis bolt and install Stop, Piper Part Number 73344-02 (left side) and 73344-03 (right side) over the bolt and reinsert bolt through the retraction arm.
3. Install washer and nut and torque 80 to 100 inch pounds.
4. Repeat procedure on the opposite gear.
5. Make proper logbook entry of compliance with PART III of this Service Letter.
