SERVICE LETTER

No. 770

Piper Aircraft Corporation

Subject: Aileron Sprocket/Chain Inspection.

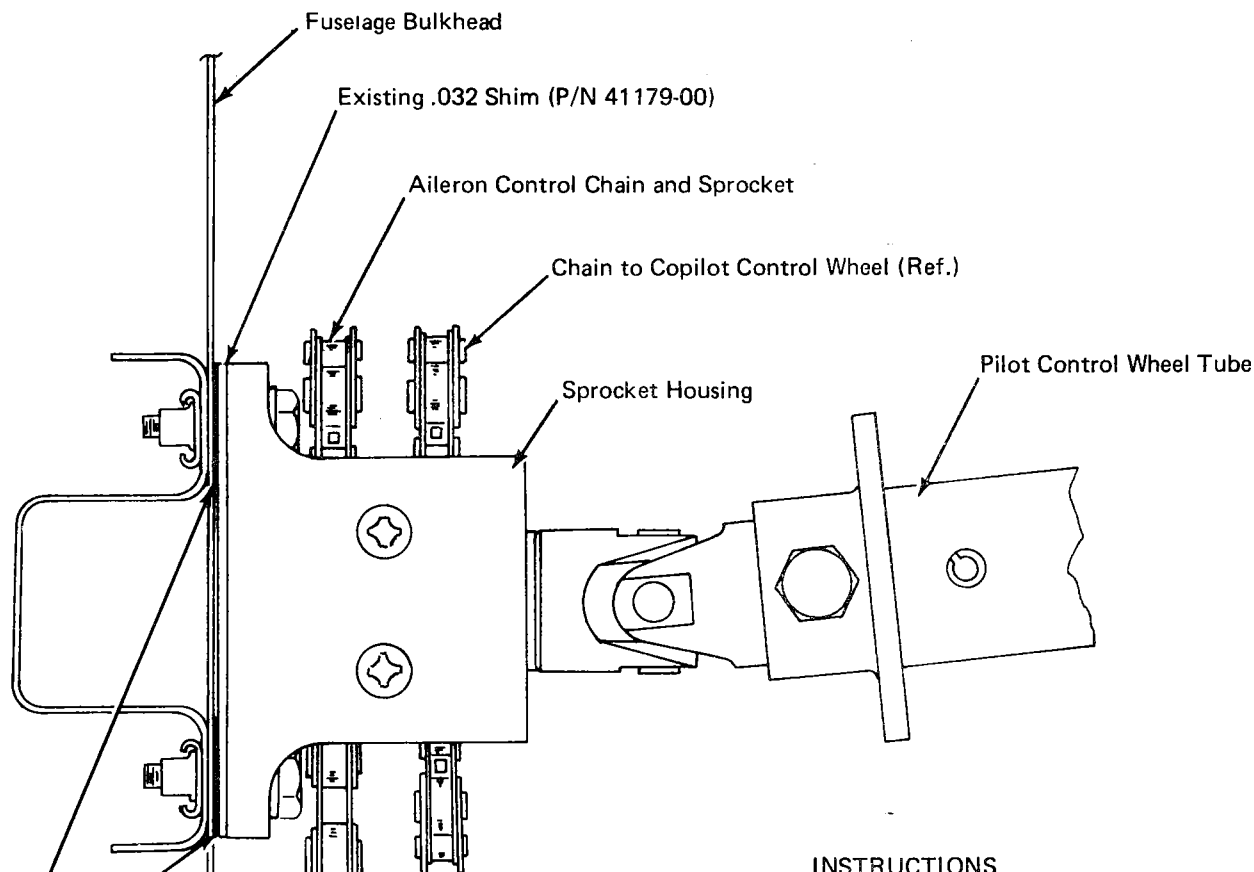
A report has been received from the field describing rough, "articulated" rotation of the pilot's control wheel. During corrective action, it was determined that the aileron sprocket and mating aileron control chain were misaligned, causing the chain to bind on the sprocket teeth. In addition to the above referenced roughness of operation, this condition, if not corrected, could cause eventual sprocket and/or chain wear.

- a. Inspect at outboard end of sprocket housing to determine if the .032 shim (P/N 41179-00) is installed between the offset in the housing and the bulkhead. Install shim (P/N 41179-00) if it is not present. This shim will ensure proper horizontal alignment.

- b. To attain proper vertical alignment, install new .012 shims (P/N 55817-02) between the top or bottom of the sprocket housing and the bulkhead, as required, to ensure a smooth flow of the chain links over the sprocket.
