SERVICE LETTER

No. 817

Piper Aircraft Corporation

Subject: Propeller Synchronizer System Refinement

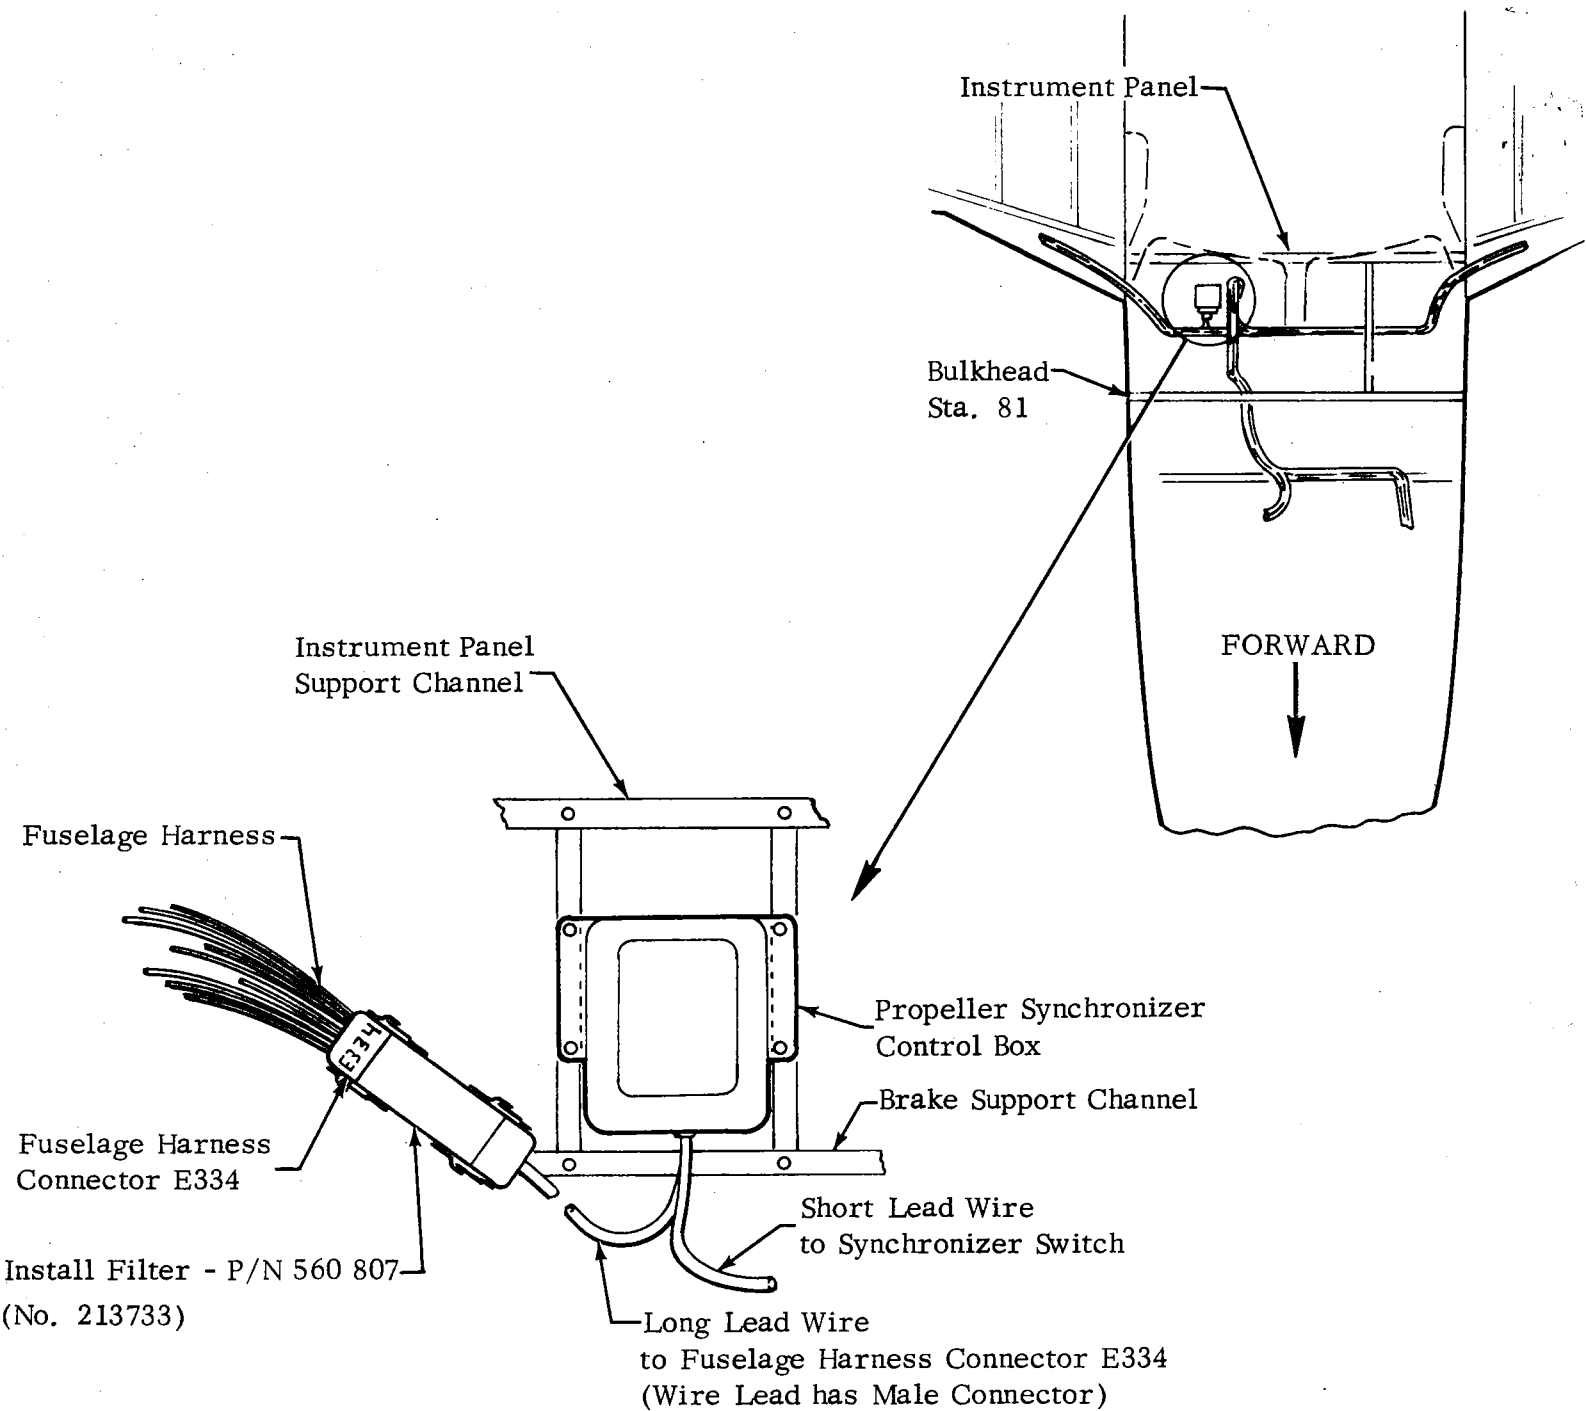
Purpose: This Service Release announces the availability of a propeller synchronizer system external filter assembly designed to eliminate external electrical interference with the synchronizer control box.

1. Locate the propeller synchronizer control box assembly behind the instrument panel.
2. Disconnect the long lead wire from the fuselage harness connector E334. (The long lead wire from the control box will have a male connector.)
3. Install filter assembly P/N 560 807 (No. 213733) between the fuselage harness connector E334 and the long lead wire as shown.
4. Make proper logbook entry of Service Letter compliance.
