VSP-34
April 14, 1982

VENDOR SERVICE PUBLICATION

Subject: B. F. Goodrich Service Letter No. 1294
(Premature 2-1435-2 MLG Brake Removal -
Clarification of B. F. Goodrich Service
Bulletin No. 399)

Models Affected: PA-31T2 Cheyenne II XL
PA-42 Cheyenne III

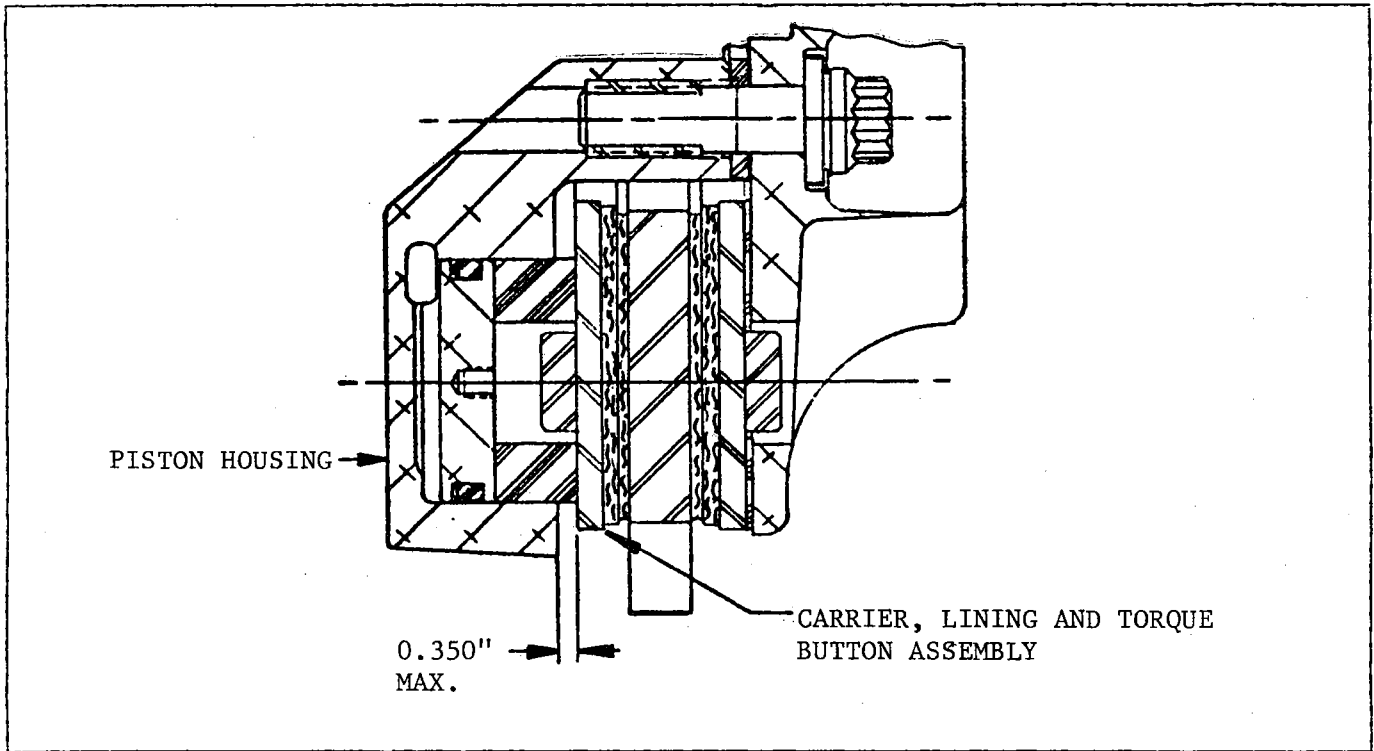
Figure 1.

- a. Pressurize brake to 100 psi; measure distance between 342-90 carrier, lining and torque button assembly and piston housing. (see Figure 1) A 0.350" or larger measurement indicates the brake should be removed for overhaul.

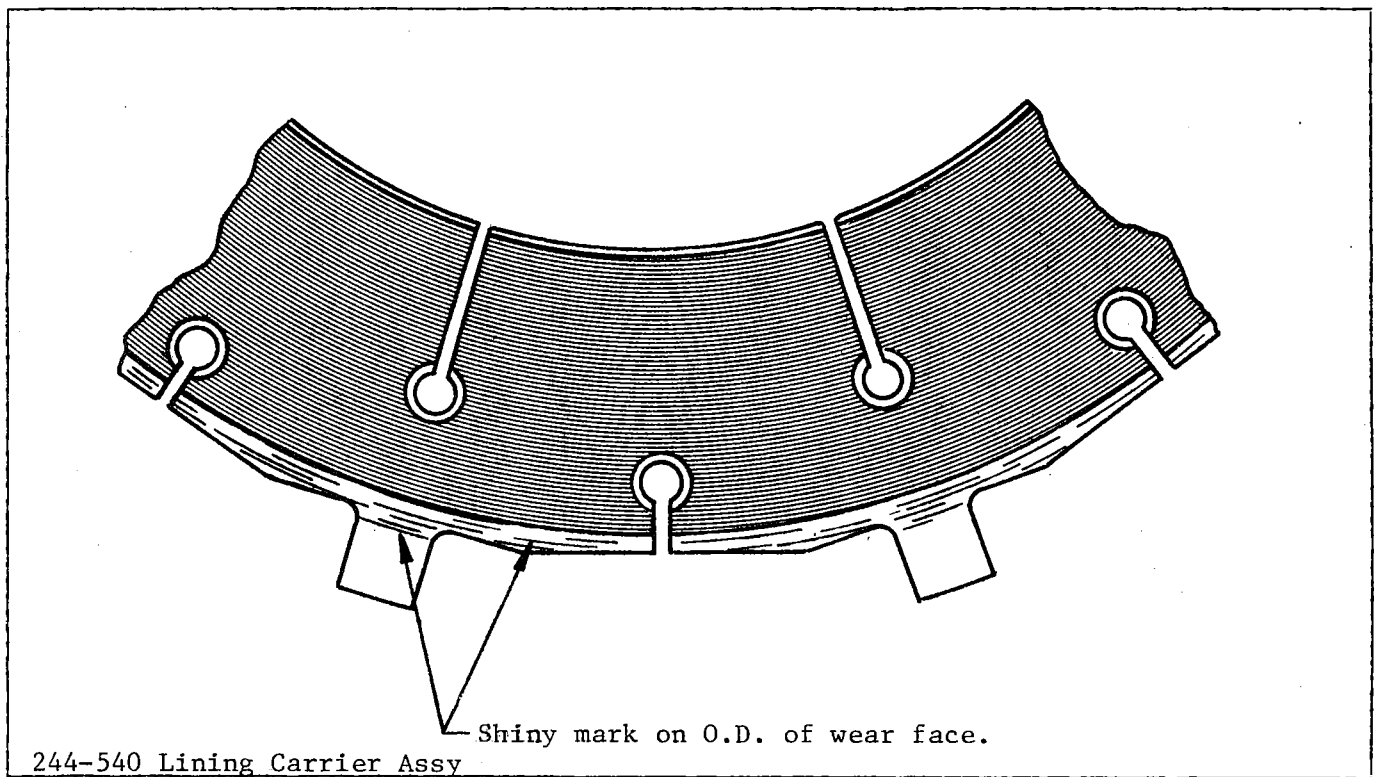
Figure 2.

- b. A shiny mark on the O.D. wear face of the 244-540 lining carrier assembly is not a criteria for brake removal. This condition is created by the 342-90 carrier, lining and torque button assembly overhanging the 244-540 lining carrier assembly. (see figure 2).

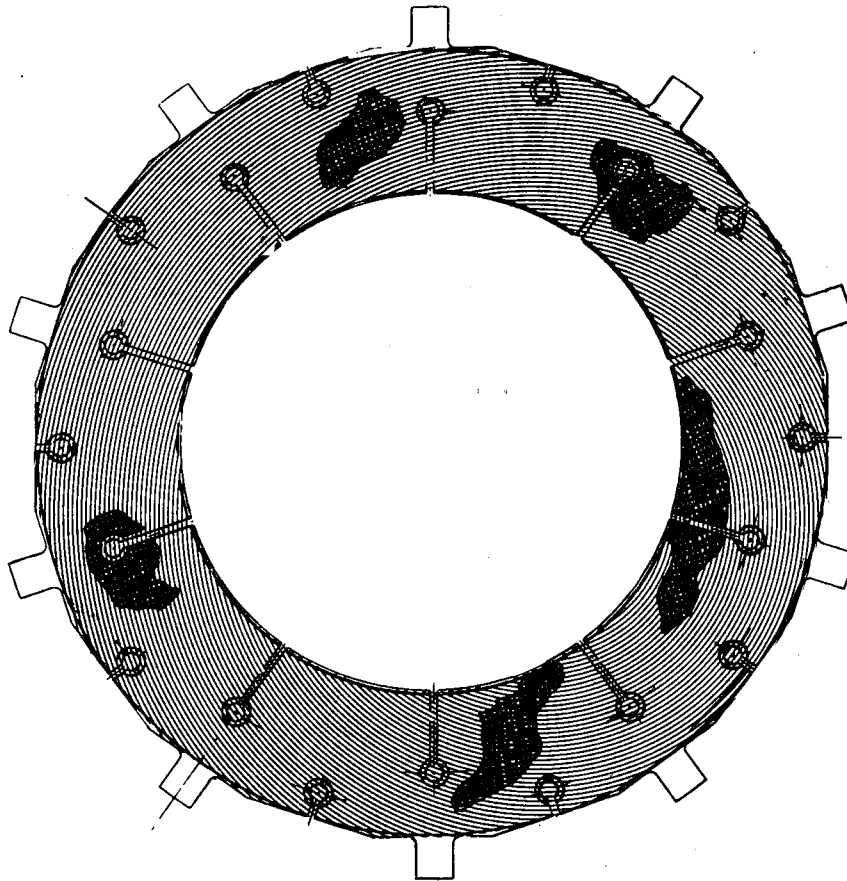
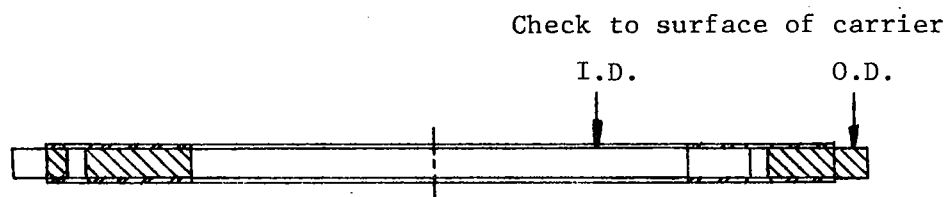
Figure 3.

2. Inspection of the brake friction material after disassembly.
- a. Inspect disk carrier and lining assembly 244-540 for a minimum thickness of .370 inches for 85% of lining surface, and dishing of .050 inches maximum from O.D. to I.D. If either or both of these conditions exist replace part. (See Figure 3)

Shaded area covers 85% of the lining surface and is worn to a minimum thickness of .370 inches.

Dishing of .050 inches maximum from O.D. to I.D.

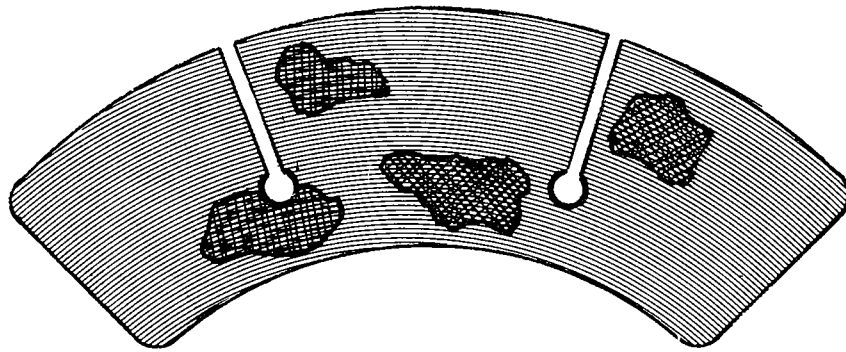
Figure 4.

- b. Inspect carrier, lining and torque button assemblies 342-90 for a minimum thickness of .160 inches for 85% of the lining surface, and dishing of .025 inches maximum. If either or both conditions exist, replace or repair part. (See Figure 4)

Shaded area covers 85% of the lining surface and is worn to a minimum thickness of .160 inches.

Check flatness on lining side of carrier. Dishing of .025 inches maximum replace or repair parts. Carrier may be cold flattened with a mallet and flat plate.

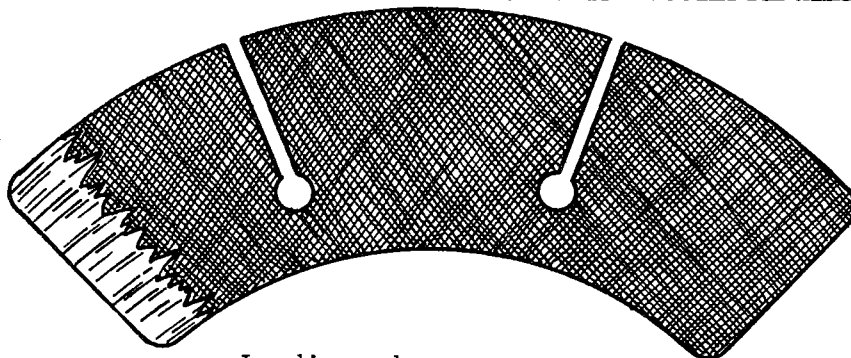
Figure 5.

- c. Leading edge wear is not a removal criterion of the carrier lining and torque button assemblies 342-90. This wear pattern can be considered normal wear. (See Figure 5)

Leading edge wear.

This condition can be considered normal lining wear.
