Piper Aircraft Corporation  
Lock Haven, Pennsylvania, U.S.A.

# SERVICE No. 294 BULLETIN

Subject: Stall Strips

Models Affected: PA-31 and PA-31-300 Navajo

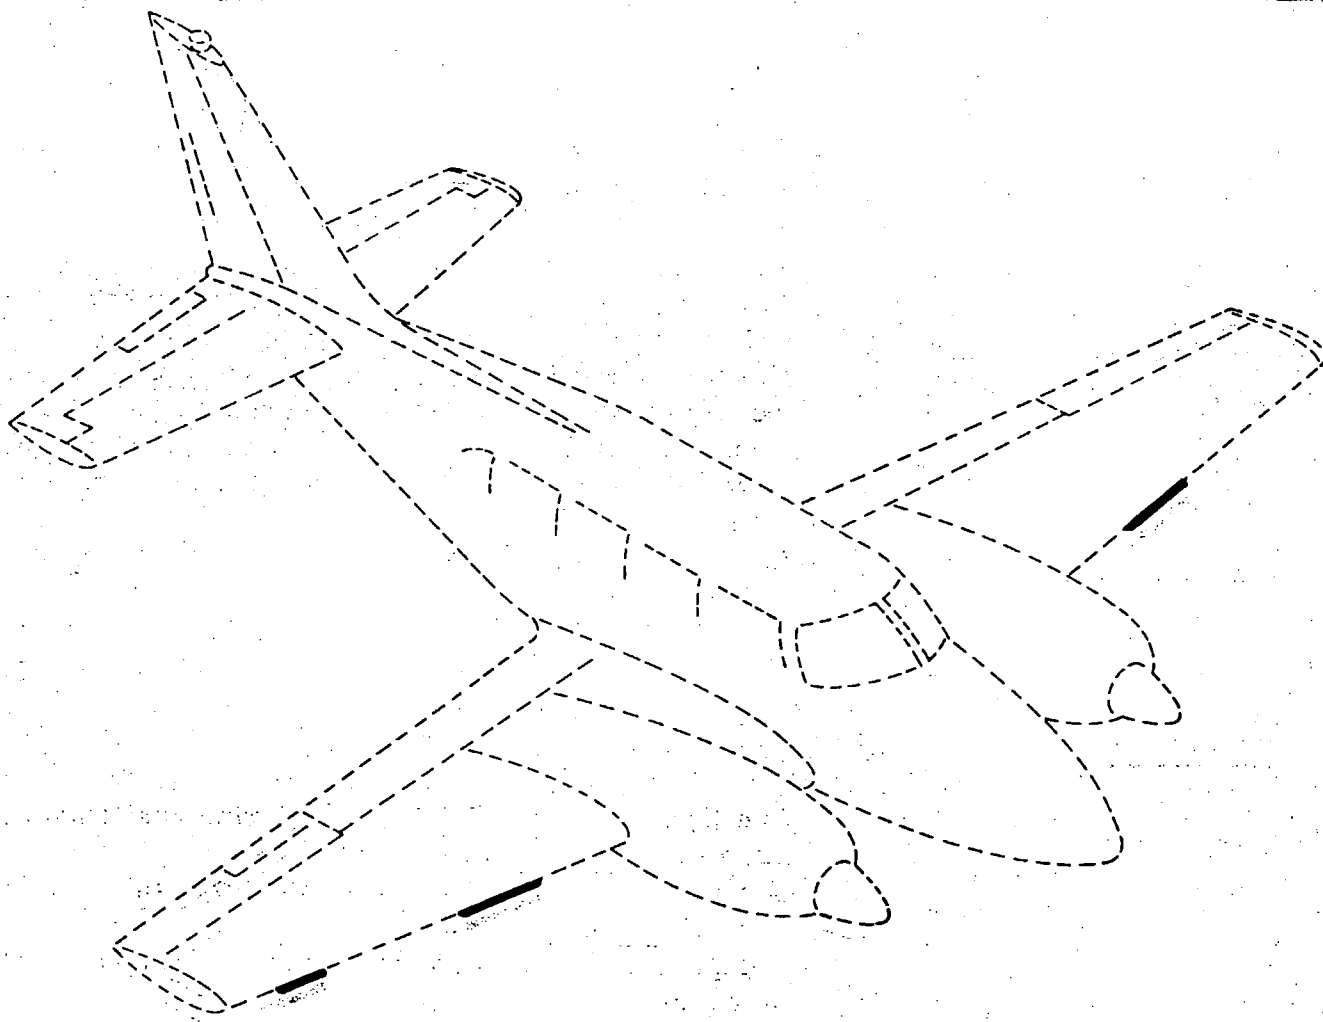
Instructions: Following the instructions contained in the appropriate stall strip installation kit, install one (1) eighteen (18) inch stall strip on the left wing, and an eighteen (18) inch strip plus a twelve (12) inch strip on the right wing. Accurate location is important and the strips must be attached in the manner specified in the kit instructions. (See sketch on reverse side of this bulletin for general information.)
