# SERVICE BULLETIN

No. 641

Piper Aircraft Corporation

Subject: Heater Fuel Drain Hose Modification

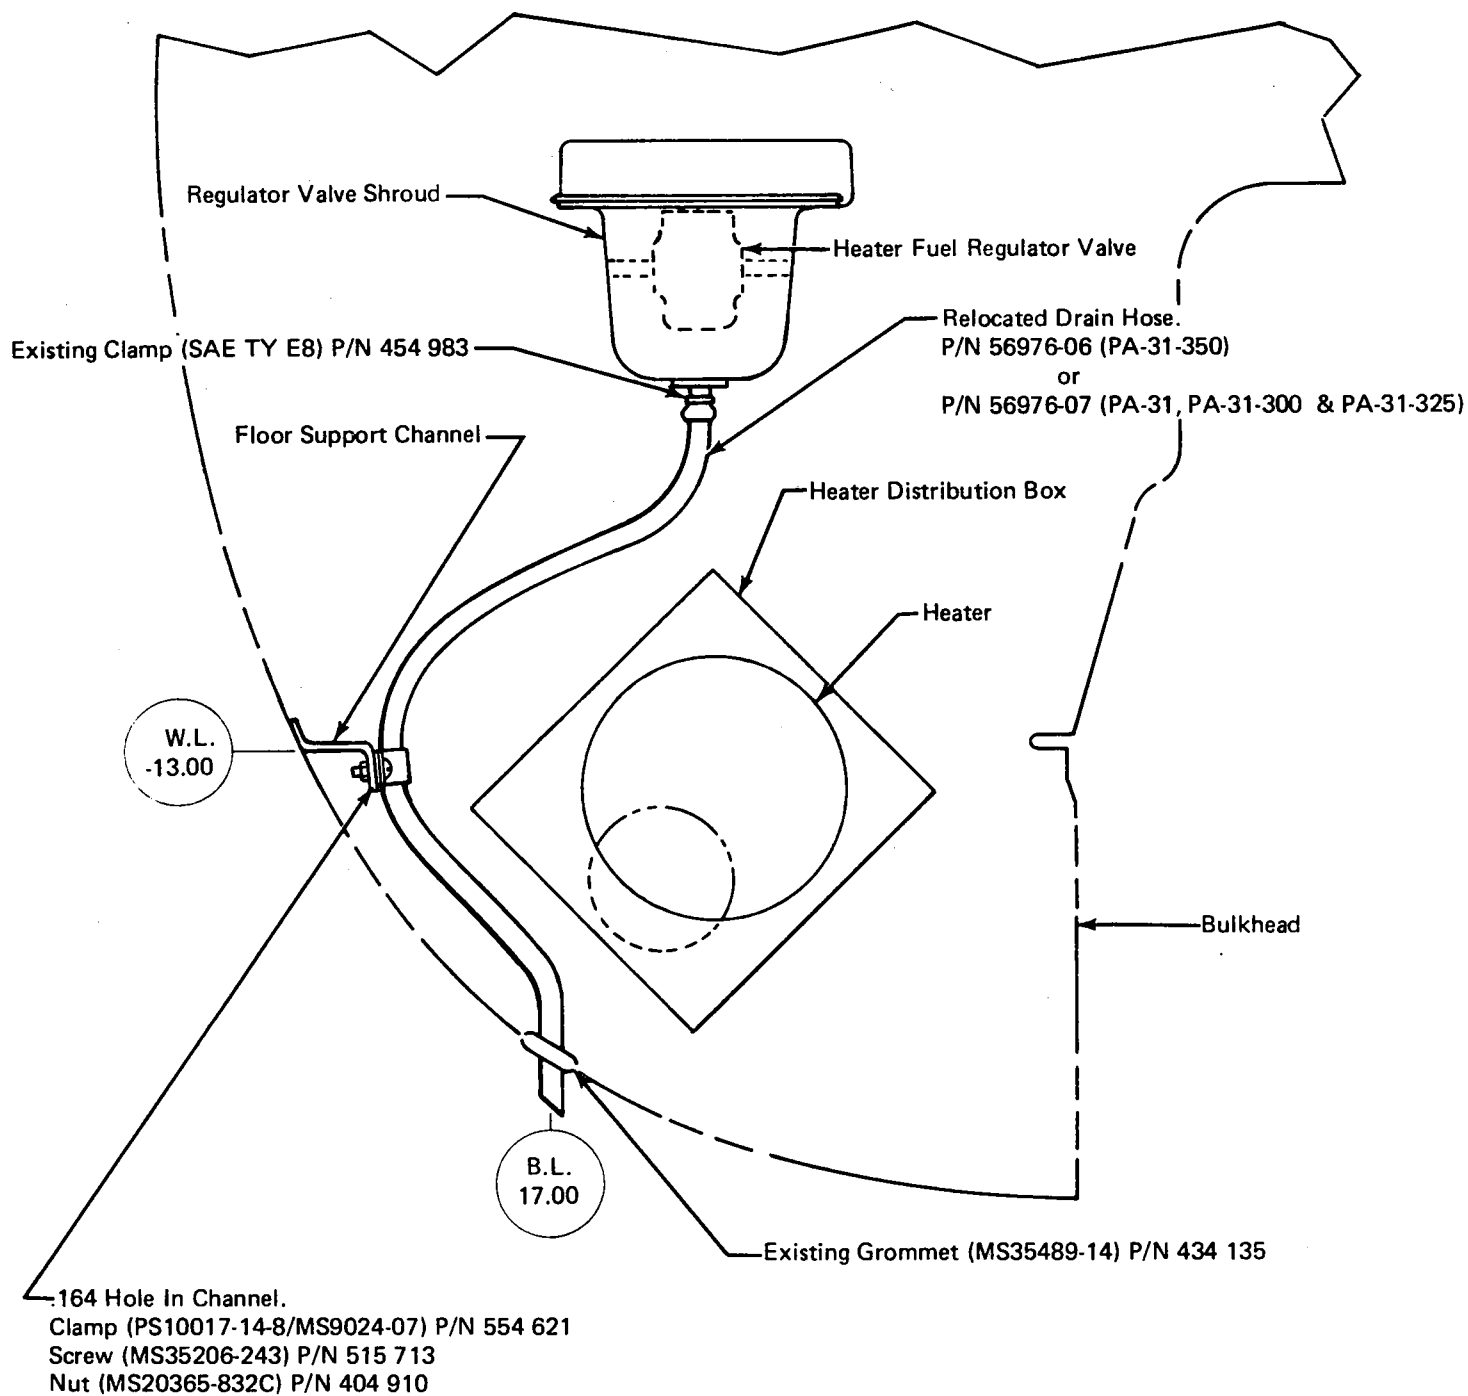
It has been determined that in the above-referenced aircraft, the Heater Fuel Regulator Drain Hose may contact the Heater Air Distribution Box. Constant contact of the Fuel Drain Hose with the Heater Air Distribution Box could cause the Fuel Drain Hose to deteriorate. A leaking Heater Fuel Regulator in combination with a deteriorated, leaking Fuel Drain Hose could allow fuel to contact the Heater Exhaust and create a fire hazard.

1. Refer to attached Sketch.
2. Remove the access panel on the right side of the fuselage to gain access to the Heater compartment.
3. The Heater Fuel Drain Hose is located on the aft bulkhead of the Heater compartment (Sta. 57 on PA-31, PA-31-300 and PA-31-325; Sta. 81 on PA-31-350).
4. Remove the clamp attaching the Fuel Drain Hose to the Regulator Valve Shroud (Avoid damaging the clamp so that it may be reused), and remove the Fuel Drain Hose from the aircraft.

5. Replace the Fuel Drain Hose with a new Hose as specified in Material Required, below, or fabricate a suitable replacement hose from 3/8" ID x 1/2" OD SAE 80 Clear Taproid (Soft PVC). For PA-31, PA-31-300 and PA-31-325 aircraft, use a 14-inch length of hose. For PA-31-350 aircraft, use a 21-inch length of hose.
6. Per the attached Sketch, drill a .164 inch hole in the channel two inches forward of the bulkhead, and install clamp, screw, and nut as shown. Refer to Material Required, below.
7. Reroute the Heater Fuel Regulator Drain Hose through the clamp as shown on the attached Sketch, assuring proper clearance from the Heater Distribution Box.
8. Reinstall access panel and make appropriate Logbook entry of compliance with this Service Release.
