SERVICE *No.884* BULLETIN

Piper Aircraft Corporation
Ft. Worth, Texas, U.S.A.

Lock Wiring of V-Band Couplings

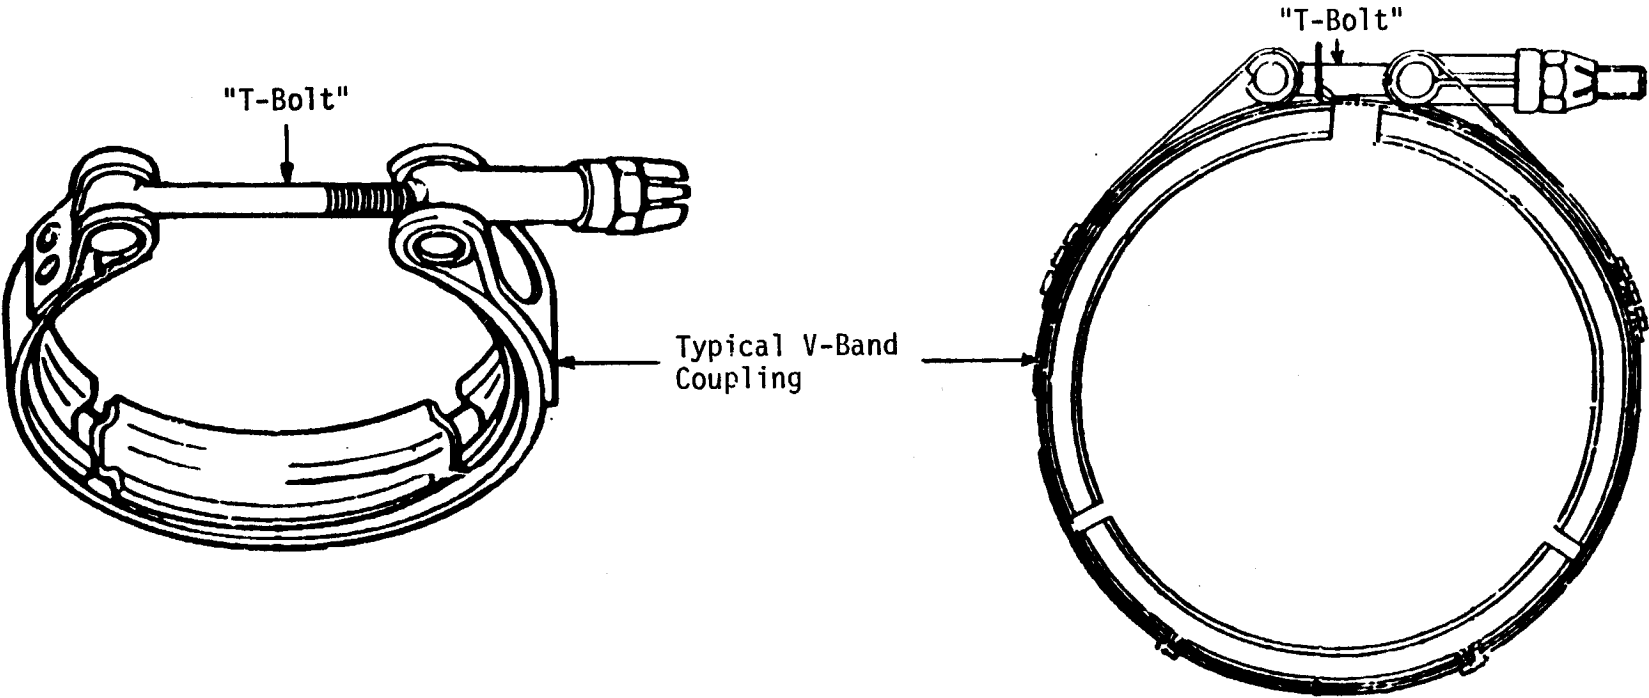
SKETCH "A"

PURPOSE: Reports have been received of broken "T-bolts" in the V-Band Couplings used in the exhaust, bleed air and cabin heat systems on various Piper Airplanes. The failure of a T-bolt can allow the coupling to separate, permitting hot exhaust gases or bleed air to be expelled, creating a fire hazard.

This Service Bulletin provides an illustration and instructions for the inspection or installation of lock wire to the V-Band Couplings. Lock wiring of the V-Band Coupling will help prevent the above described condition, should failure of a "T-bolt" occur.

1. Refer to the applicable parts catalog to determine the number and location of V-Band Couplings on the affected aircraft.
2. Inspect all V-Band Couplings for security and integrity of T-bolts and lock wire (if installed). Refer to Sketch "A" attached.
3. If lock wire is damaged or missing, lock wire coupling using MS20995-C41 wire. Refer to Sketch "A".
4. Make an appropriate logbook entry of compliance with this Service Bulletin.

MS20995-C41 Wire, As Required.
