# SERVICE BULLETIN

No. 591

Piper Aircraft Corporation

Subject: Inspection of Goodyear BTC-39 Fuel Cells

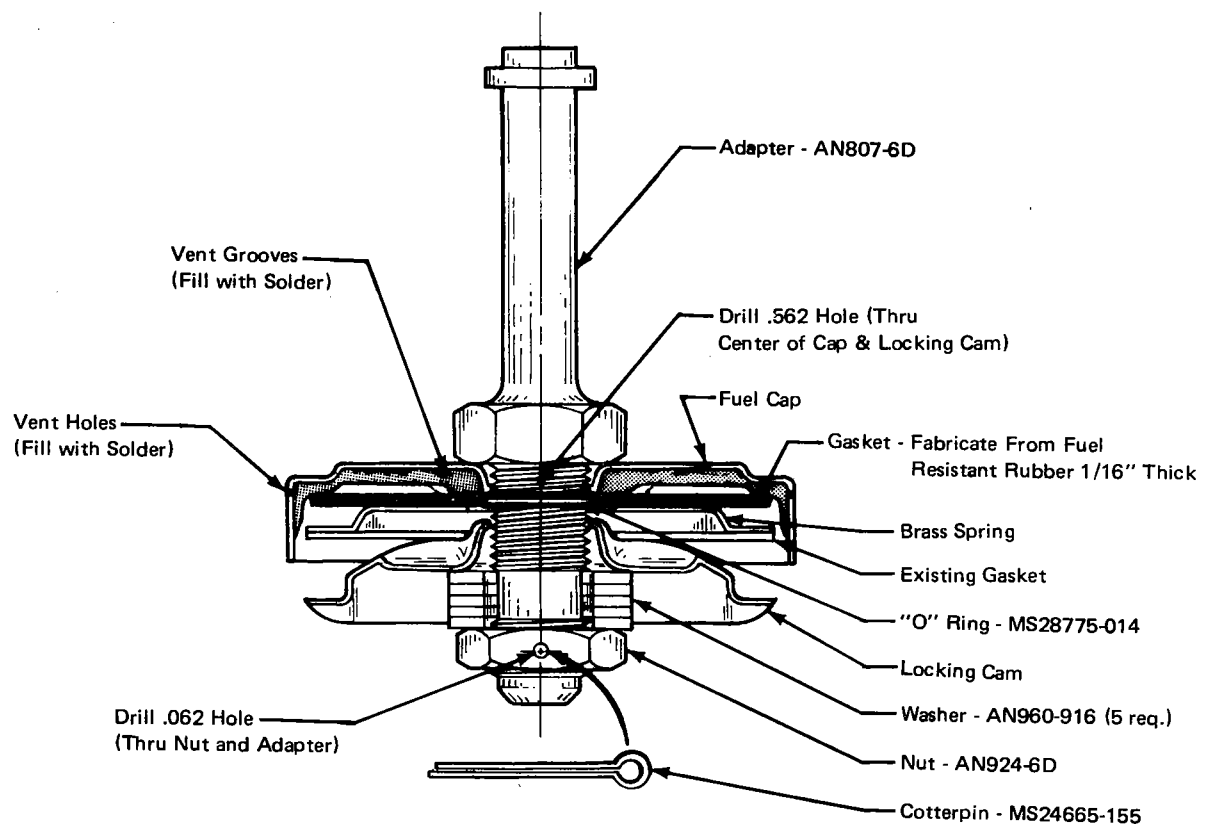
**FIGURE 2**

Reworked Fuel Cap (PAC P/N 60707-04)

2. Obtain a fuel cap, PAC Part No. 60707-04, and rework for this test as follows. (Refer to Figure 2 on Sketch "A").
    - a. Drill out rivet in center of fuel cap. Remove locking cam, gaskets and brass spring from cap.

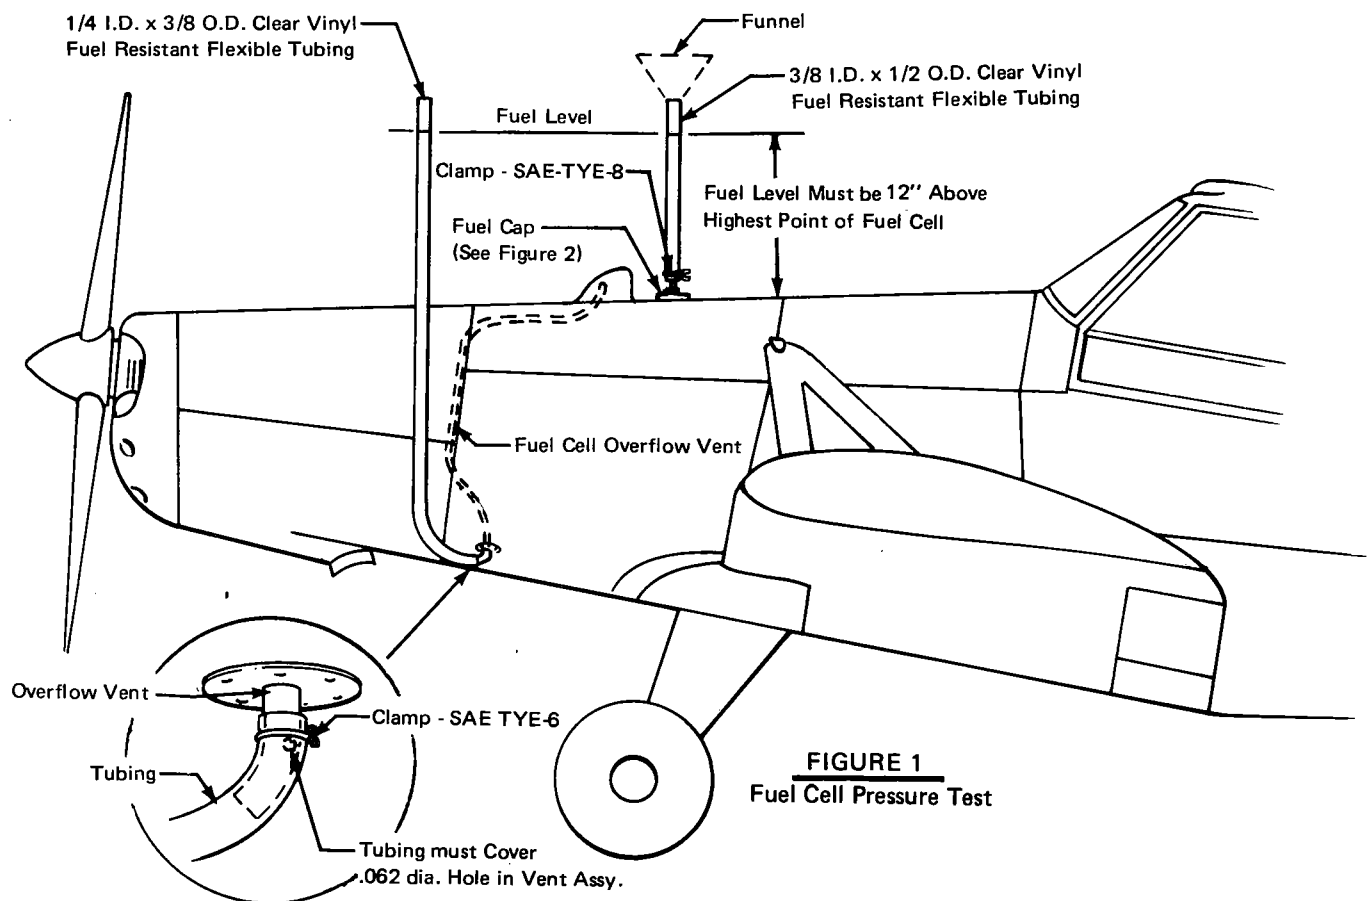
**FIGURE 1**

Fuel Cell Pressure Test

3. Install reworked fuel cap on fuel cell.
  4. Refer to Figure 1. Install a section of flexible tubing to the fuel cap adapter and the overflow vent as shown. Tubing must extend at least 12" above highest point of fuel cell. (Insure that .062 dia. hole in overflow vent is covered with tube.)

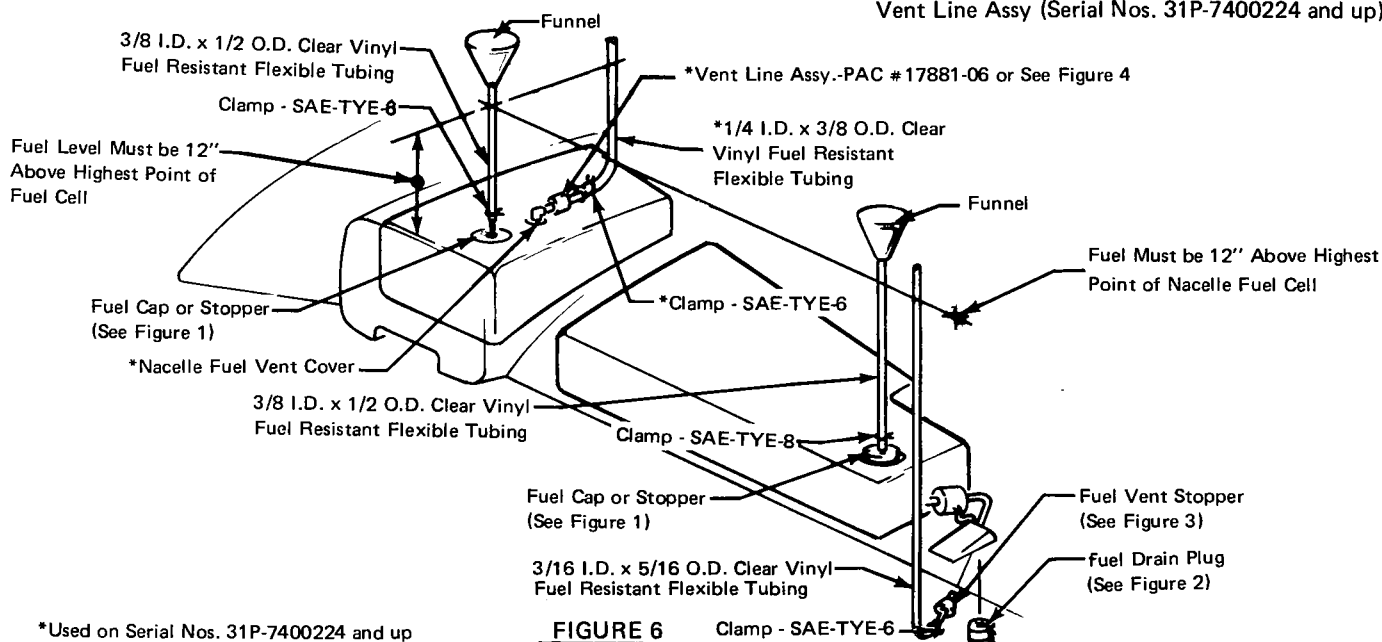
**FIGURE 6**  
Nacelle and Auxiliary Fuel  
Cell Pressure Test

- (2.) If there is evidence of fuel leakage or seepage from the fuel cells, refer to the attached Goodyear Service Bulletin FT-77-1 and inspect both fuel cells per Section II. Any fuel cell found with cracking, peeling or deteriorated cell interior and/or deteriorated nipples must be replaced. (Refer to PA-31P Navajo parts catalog and service manual for fuel cell ordering information and installation details.)

6. Refer to Figure 6 and pressure test the auxiliary and nacelle fuel cells simultaneously as follows:
  - a. Attach fuel drain plug to drain on bottom of wing as shown.

- d. Remove nacelle and auxiliary fuel caps from fuel cells and fill with fuel. Retain fuel caps for reinstallation.
  - e. Install fuel caps or stoppers, that were reworked per Figure 1, on auxiliary and nacelle fuel cells.
