Service Letter No. 508

Subject: Propeller Counterweight Attachment Bolt Clearance

Models Affected: PA-31, PA-31-300 Navajos

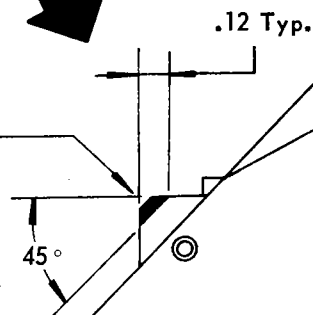
Instructions: If evidence of bolt scoring in the spinner is detected, the bolt head must be reworked per the Hartzell approved rework procedure as illustrated on the sketch on the reverse side of this letter.

The maximum allowable depth of scoring by the propeller counterweight attachment bolt in the propeller spinner shall not exceed .010 inch. If this dimension is exceeded, the spinner must be replaced. Propeller spinner scoring of .010 inch or less must be dressed out to relieve any stress concentration areas.

Remove this amount of material from bolt head if necessary.
Paint surface with metal primer or equivalent protective paint.
