VSP-33
December 18, 1981

VENDOR SERVICE PUBLICATION

To: All Piper Distributors and CORPAC's
Subject: Bendix Service Bulletins 611, 616, 617, 619

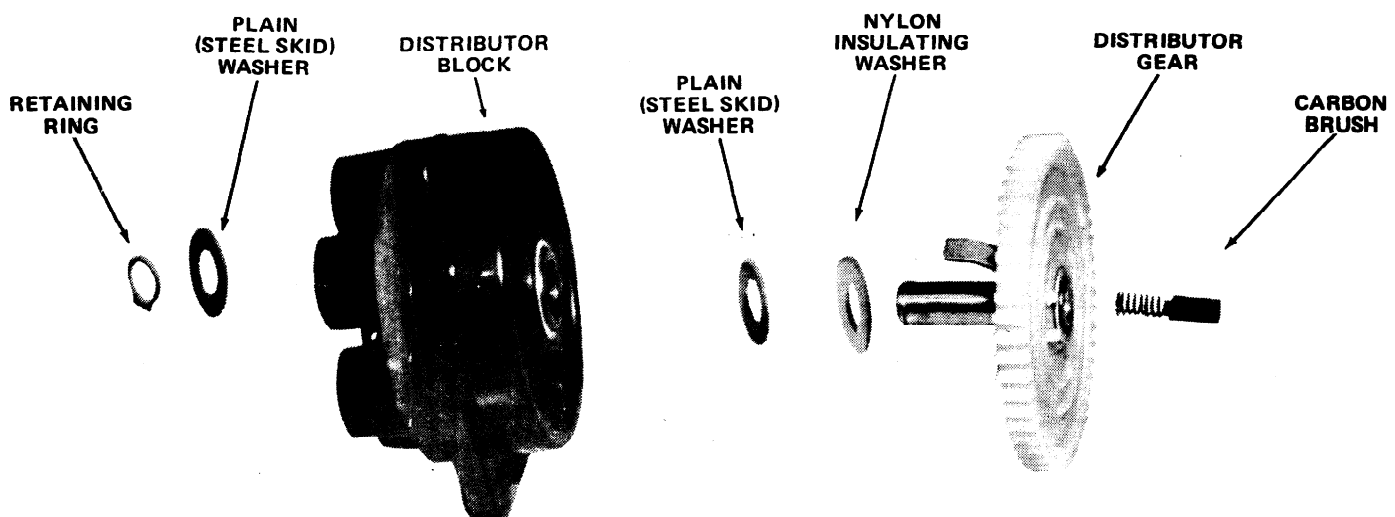
Figure 1. Exploded View

The 10-357584 and 10-357586 Insulated Distributor Gear Kits for S-20 and S-200 Series Magnetos are being provided as a standardization change for Bendix magnetos. With the introduction of these kits, all new Bendix aircraft magnetos delivered from the factory will be provided with insulated distributor gears. The insulated gear kits include all parts (except distributor block) as identified in figure 1.

Assembly sequence of the gear kit to distributor block is shown in the exploded view of figure 1.

When timing magneto on bench or when reinstalling magneto on engine no gear holding timing device should be used, as hidden gear tooth damage may result.
