# SERVICE *No. 1041* BULLETIN

**Distribution of Airborne Service Letter Number 56,  
"Inspection and Cleaning of Airborne Air Filter Elements"**

**Service Letter Number:** 56

**Subject:** Inspection and Cleaning of Airborne Air Filter Elements.

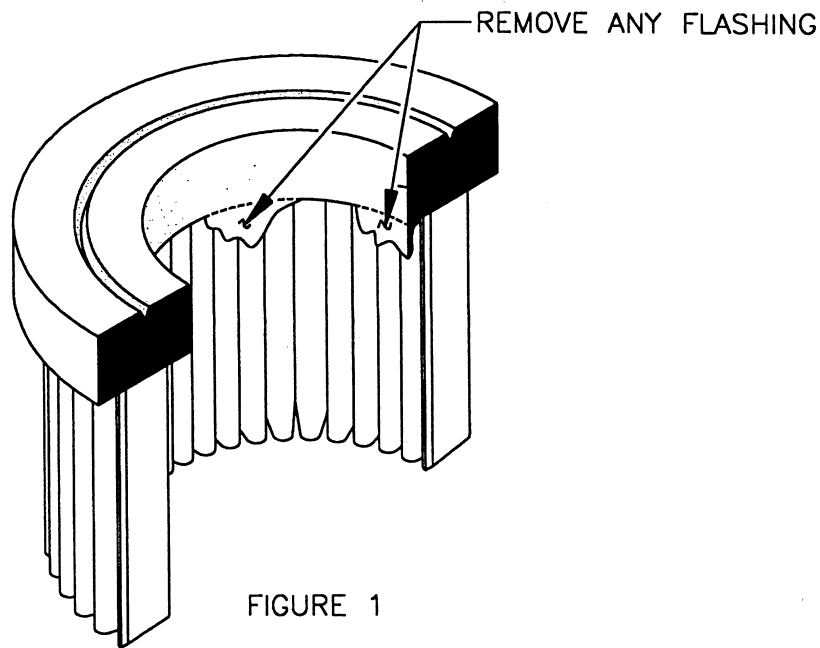
- 1) Remove the affected air filter element from aircraft per the instructions outlined in the appropriate maintenance/service manual provided by the airframe manufacturer.
- 2) Inspect the inner diameter of the black end piece(s) of these elements for flashing (Figure 1). Remove all flashing using a sharp knife. Caution: Do not cut the paper filter portion of the element.

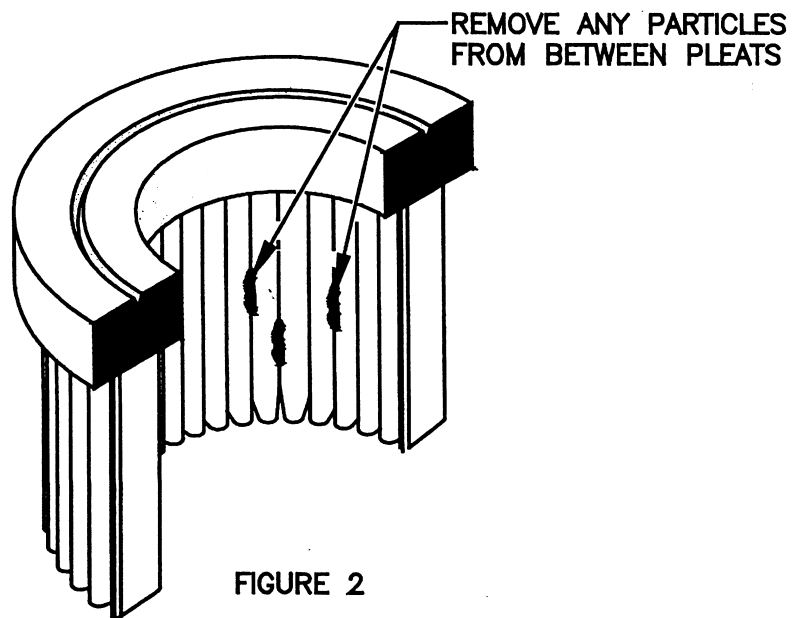
- 3) Tap the element lightly on a clean work surface in order to remove any loose particles from between the pleat tips on the inside of the paper filter (Figure 2).

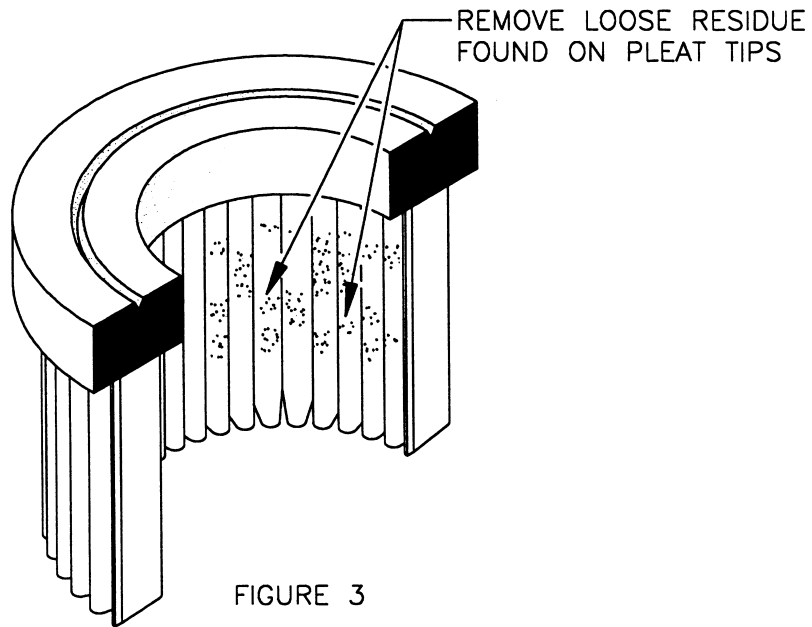
- 4) Inspect the inner diameter (pleat tips) of the paper filter for black residue (Figure 3). Remove all loose residue using the "sticky side" of a strip of masking tape attached to the end of a blunt instrument.

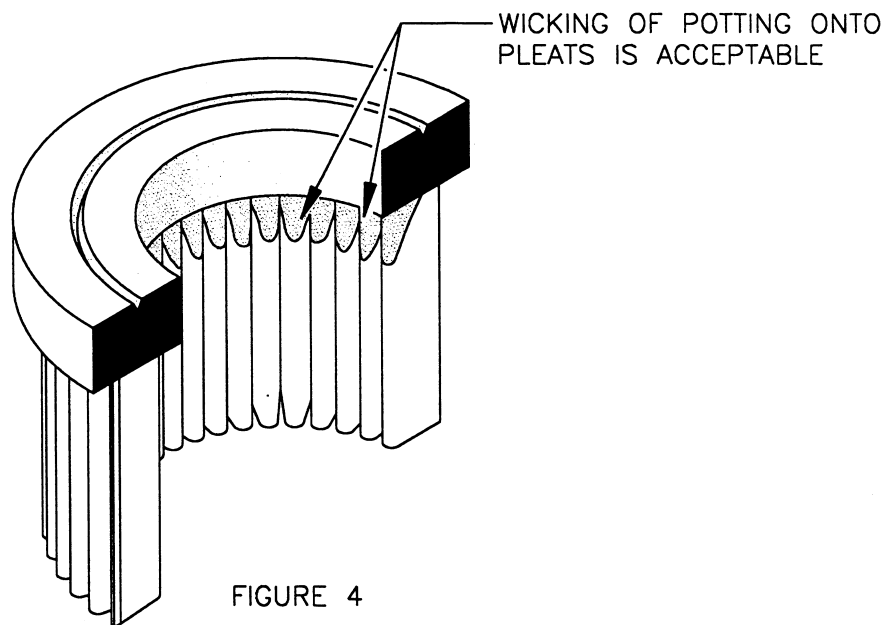
- 6) Thoroughly inspect all internal surfaces of the element for any loose particles. Remove any remaining loose particles using any combination of the above steps. Note: The wicking of black potting material onto pleats of paper filter is acceptable (Figure 4).
