SERVICE LETTER

No. 690A

Piper Aircraft Corporation

Engine Cylinder Baffle Removal and Cylinder Head Temperature Probe Relocation

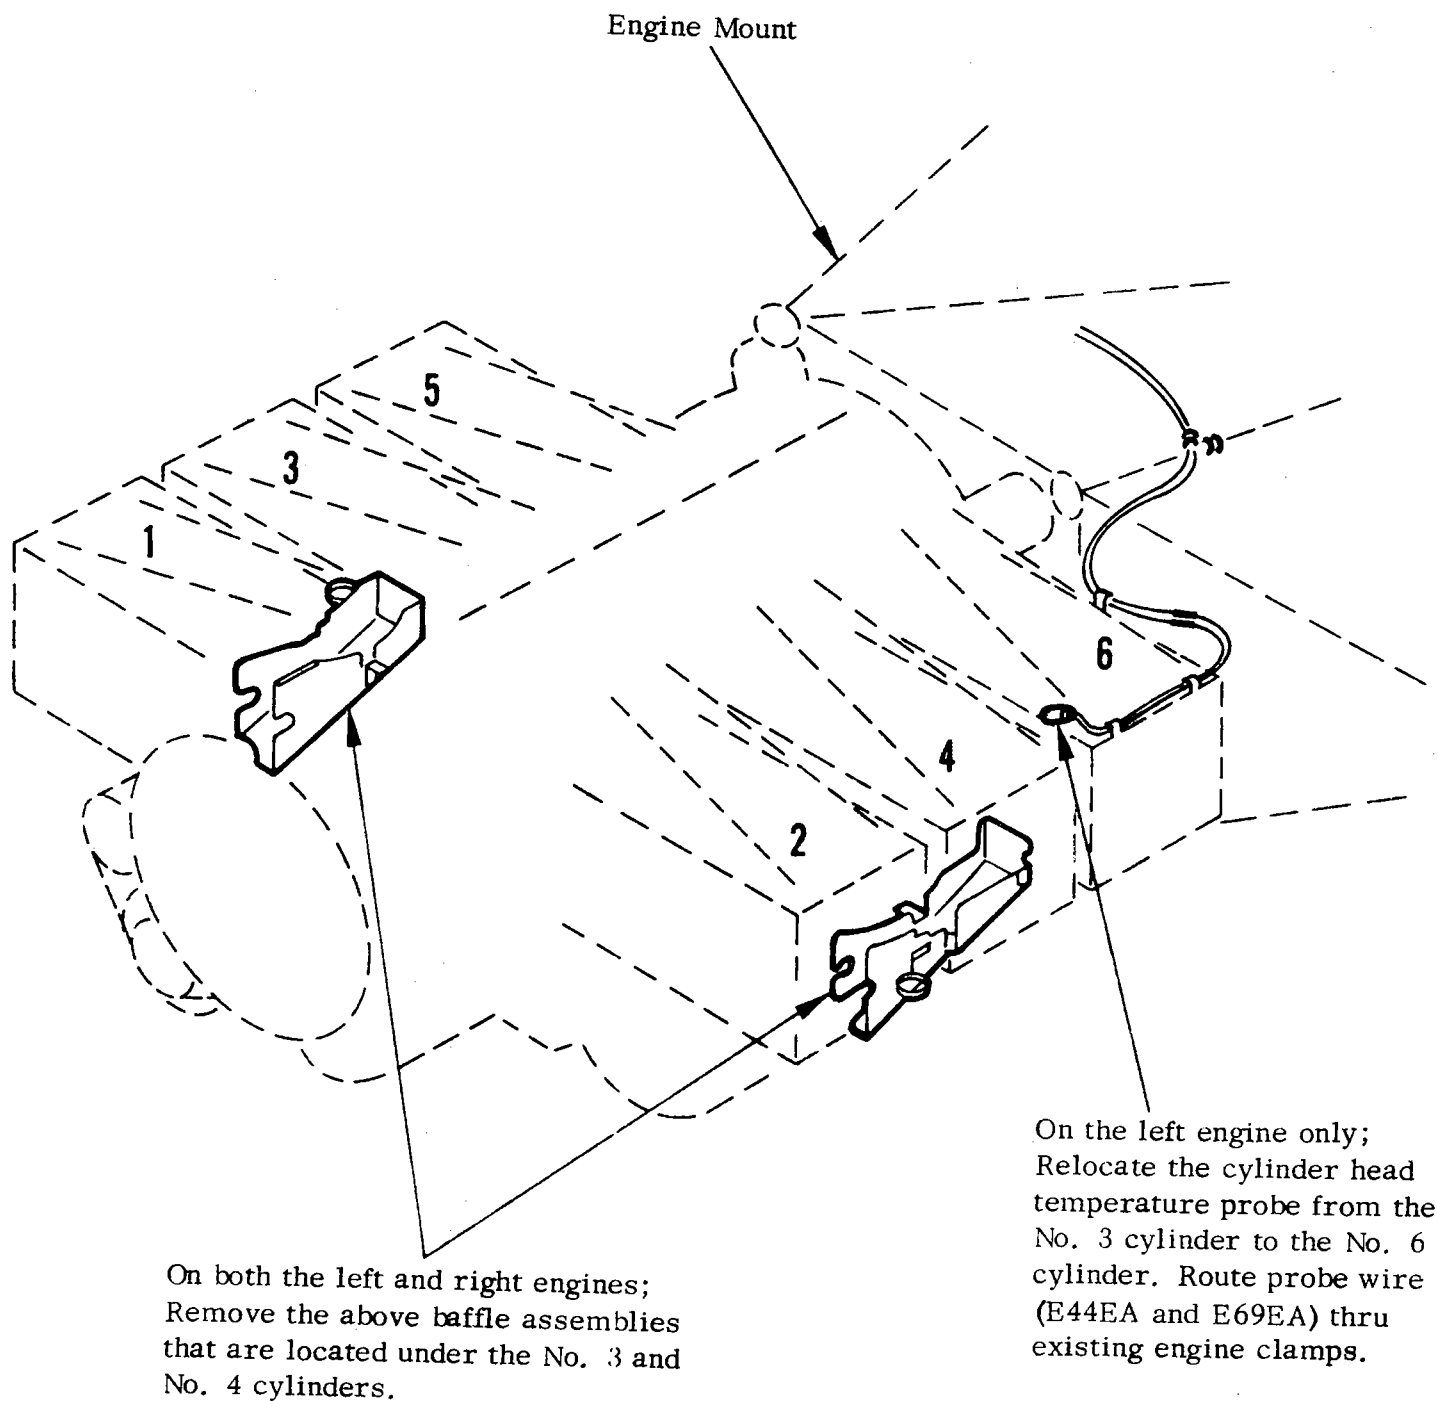
Therefore, to coincide with current production installations, this service release provides instructions to remove the above referenced engine cylinder baffles and (resulting from the removal of the No. 3 cylinder baffle) to relocate the cylinder head temperature probe from its original location on the No. 3 cylinder to the No. 6 cylinder. Baffle removal relates to both engines and the cylinder head temperature probe relocation relates to the left engine only (refer to sketch on the reverse side of this service release for a pictorial description).

Contained on sketch/instruction sheet on reverse side of this service release.

It has been determined from a continuing series of flight tests, that the engine No. 3 and No. 4 cylinder baffles (Piper Part No. 53390-00 - left and Part No. 53394-00 - right) could be removed from the engine compartment without affecting engine cooling. Current production aircraft no longer include the engine No. 3 and No. 4 cylinder baffles.
